**BMW 5 TOURING: 1JRC486**

**Limited Technical Inspection**

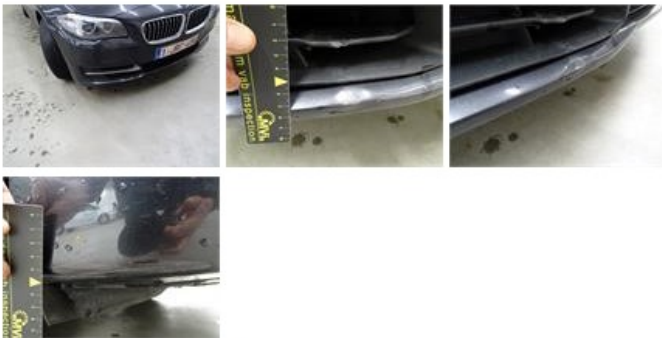
Rearview mirror basis L, Scratch(es), Acceptable	0,00
<i>No pictures to display</i>	
Door R R, Scratch(es), Acceptable	0,00
<i>No pictures to display</i>	
Rearview mirror basis R, Scratch(es), Acceptable	0,00
<i>No pictures to display</i>	
Bumper R, Scratch(es), Acceptable	0,00
<i>No pictures to display</i>	
Bumper F, Dent(s) and scratch(es), LI - Repair and paint (complete)	254,16
