CITROËN C4 Picasso: 1GDV378

Limited Technical Inspection

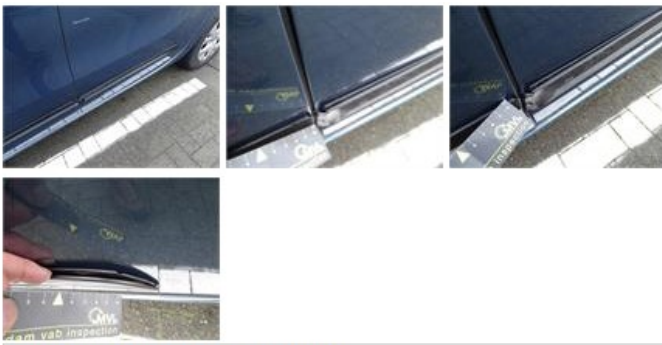
Door R L, Bad repair, P - Check	0,00
---------------------------------	-------------

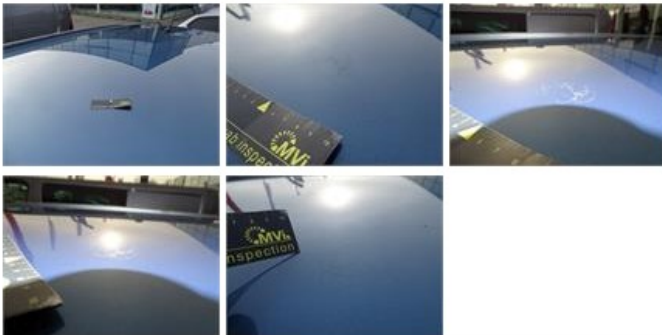
Roof, Chemical pollution, LI - Repair and paint (complete) 481,50
