RENAULT Captur: 1GKS870

Limited Technical Inspection

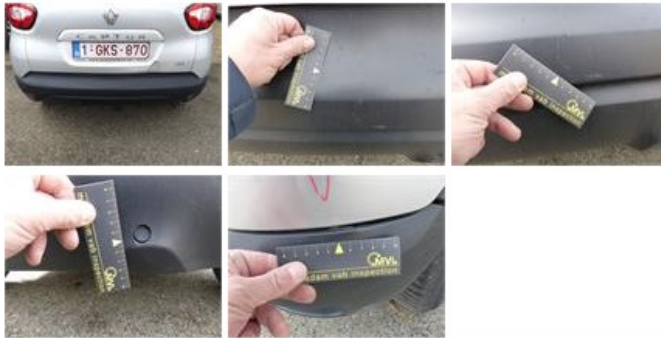
Bumper R, Scratch(es), Smart repair
