TOYOTA Auris: 1GMF404

Limited Technical Inspection

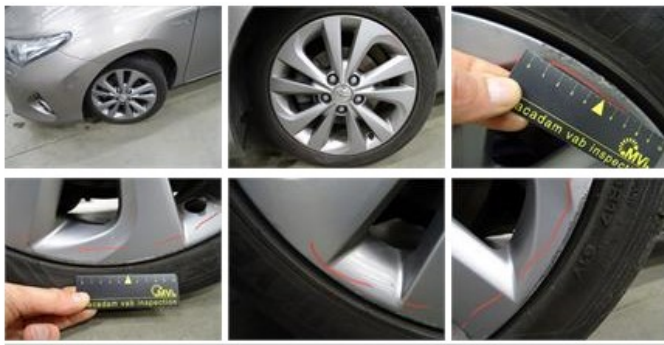
Repair kit	Yes	Compressor	Yes
Total cost ex VAT			1597,88
Door F L, Scratch(es), Acceptable			0,00
<i>No pictures to display</i>			
Alloy rim F L, Scratch(es), LI - Repair and paint (complete)			95,00

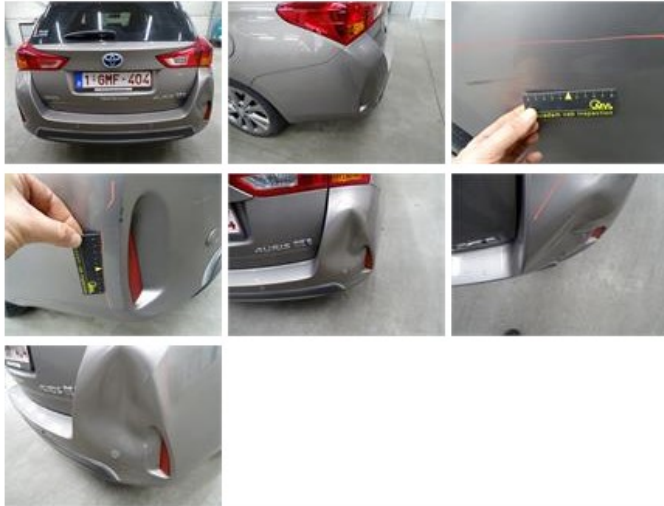
Bumper R, Dent(s) and scratch(es), Le - Replace and paint

651,00

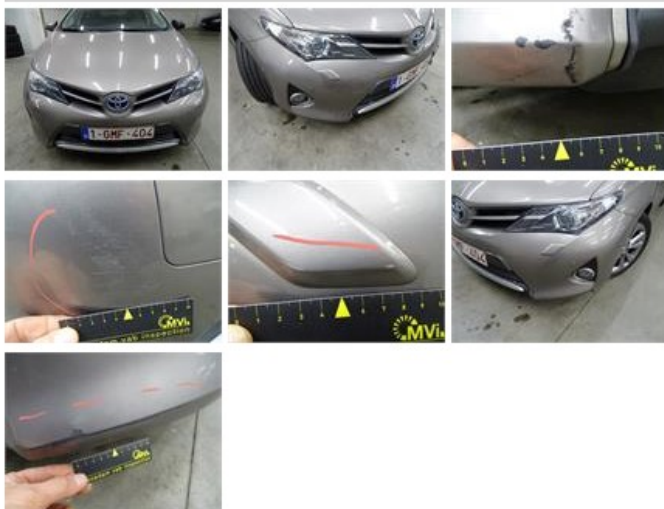
Bumper F, Scratch(es), LI - Repair and paint (complete)

211,80

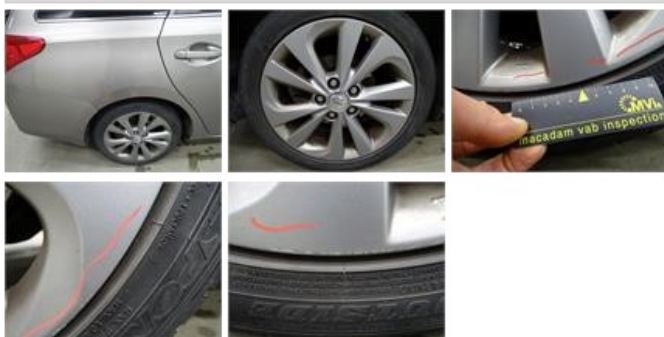
Alloy rim R R, Scratch(es), LI - Repair and paint (complete)

95,00

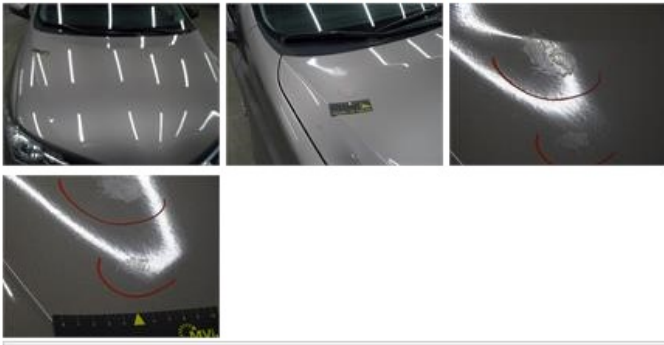
Bonnet, Chemical pollution, LI - Repair and paint (complete)

290,08

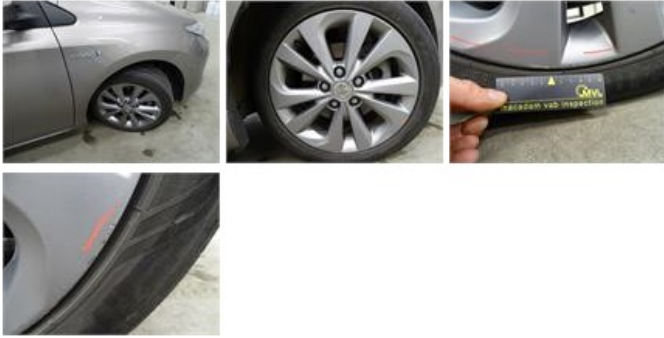
Alloy rim F R, Scratch(es), LI - Repair and paint (complete)

95,00
