VOLKSWAGEN Golf: 1GMK937

Limited Technical Inspection

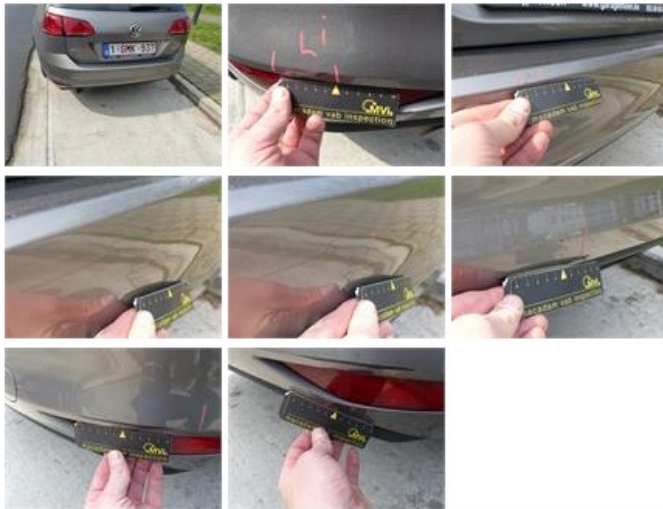
Bumper R, Scratch(es), LI - Repair and paint (complete) 211,80

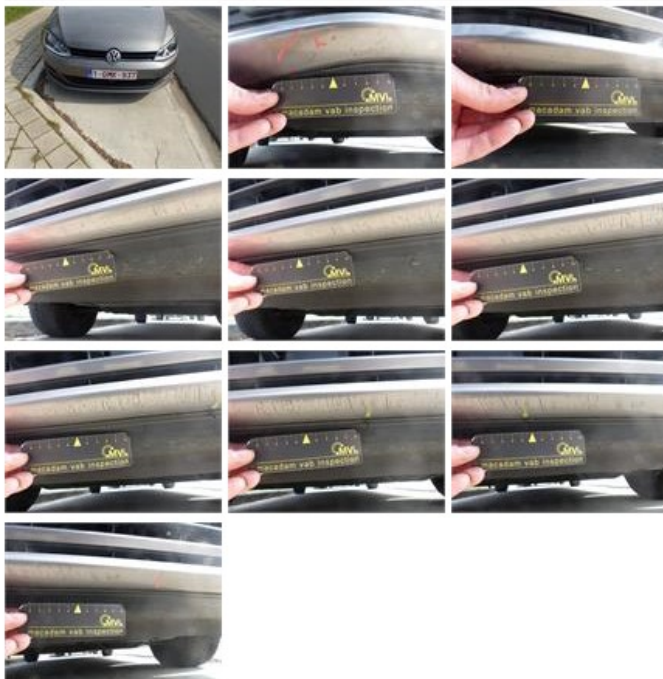
Bumper F, Scratch(es), LI - Repair and paint (complete) 211,80
