TOYOTA Auris: 1FLM523

Limited Technical Inspection

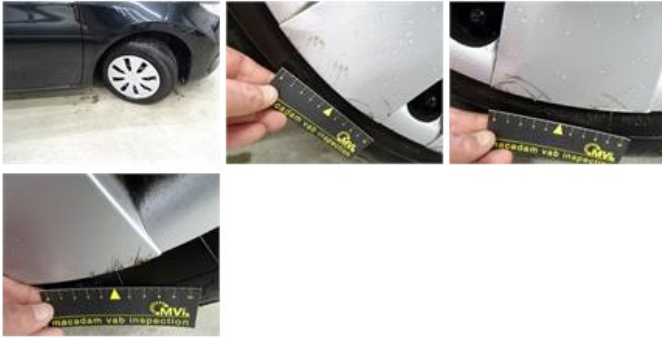
Wheel cover F R, Scratch(es), E - Replace 30,00

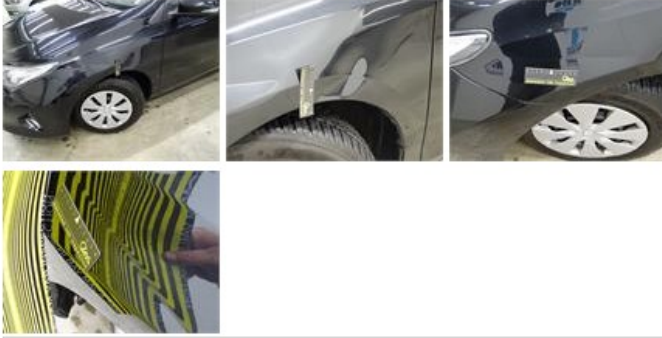
Wing F L, Dent(s) and scratch(es), LI - Repair and paint (complete) 316,18
