HYUNDAI ix35: 1GPU476

Limited Technical Inspection

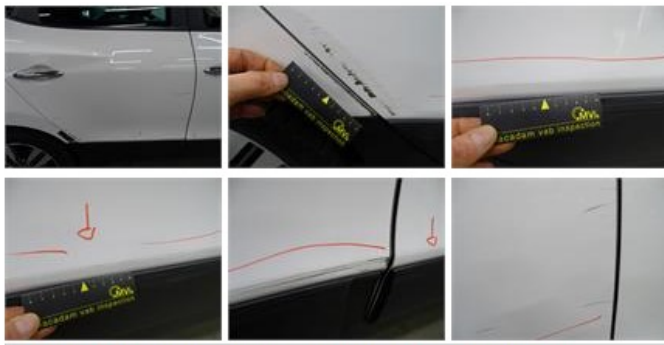
Door R R, Dent(s) and scratch(es), LI - Repair and paint (complete)	318,35
---	---------------

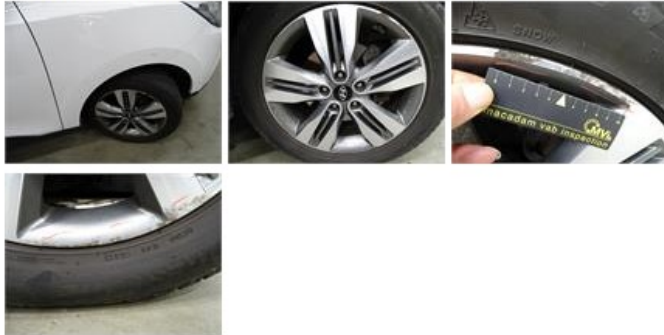
Alloy rim F R polished, Scratch(es), LI - Repair and paint (complete)

95,00

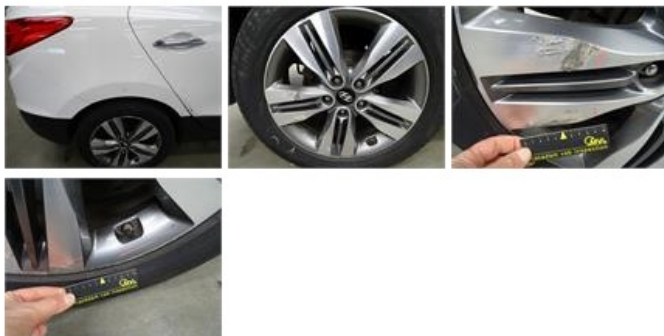
Alloy rim R R polished, Scratch(es), LI - Repair and paint (complete)

95,00

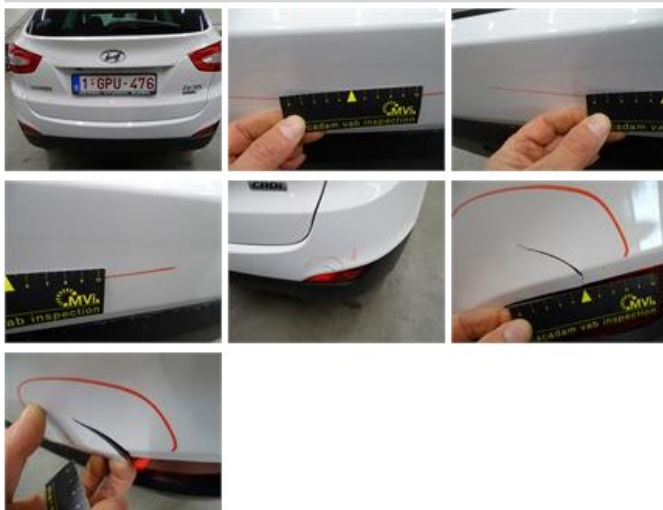
Bumper R, Broken, LI - Repair and paint (complete)

211,80
