FORD Galaxy: 1JGT241			
Vinnumber:	WF0MXXGBWMEG18109	Versionname:	GALAXY Trend Style St/St DPF 115PK
First Registrationdate:	15/12/2014	Fiscalpower:	
Expertise Mileage:	110499	Power Kw:	85
Bodytype:		Body color:	Black
Gearbox:	MAN 6 VIT	Paint type:	Metallic
Transmission:	Front	Rims summer:	Aluminium
Fueltype:	Diesel	Oil level:	OK
Battery functioning:	Yes	Parking lot:	4710
Number of doors:	5		
Number of seats:	7		
Number head rests:	7		
Rims summer:	Aluminium		
Category:	Passenger Car		
Oil level:	OK		
Registration Certificate Car (BE):	Yes

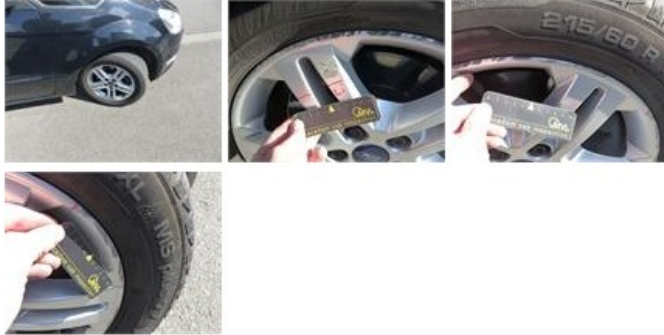
<i>No pictures to display</i>		
Door F R, Dent(s), Acceptable		0,00
<i>No pictures to display</i>		
Wing R L, Dent(s), Acceptable		0,00
<i>No pictures to display</i>		
Roof, Scratch(es), Acceptable		0,00
<i>No pictures to display</i>		
Outer backrest protection L, Scratch(es), Acceptable		0,00
<i>No pictures to display</i>		
Ceiling, Stain, Acceptable		0,00
<i>No pictures to display</i>		
Wing R L, Repaired, Acceptable		0,00
<i>No pictures to display</i>		
Glove compartment lid, Scratch(es), Acceptable		0,00
<i>No pictures to display</i>		
Door R L, Scratch(es), Acceptable		0,00
<i>No pictures to display</i>		
Alloy rim F R, Scratch(es), LI - Repair and paint (complete)		95,00

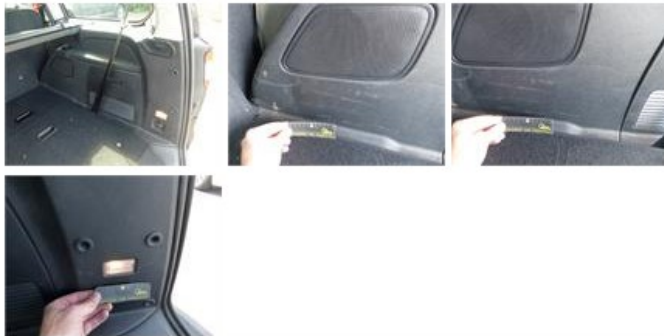
Internal Boot Lining R, Scratch(es), Smart repair		110,64
---	--	--------

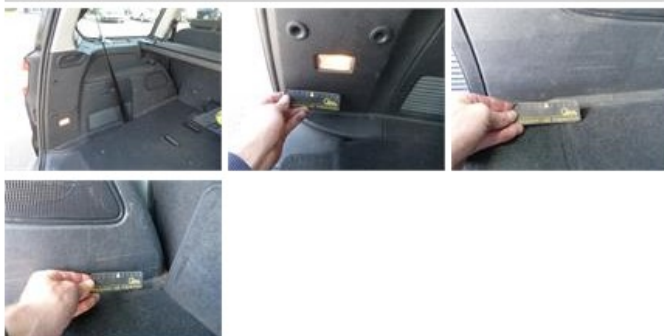
Bumper corner R L, Repaired, Acceptable		0,00
<i>No pictures to display</i>		
Tires, Not original part, Acceptable		0,00
<i>No pictures to display</i>		
Bumper F, Stone chip(s), Acceptable		0,00
<i>No pictures to display</i>		
Trunk lid covering R, Scratch(es), Acceptable		0,00
<i>No pictures to display</i>		
Wing F R, Scratch(es), Acceptable		0,00
<i>No pictures to display</i>		
Wing R R, Dent(s) and scratch(es), Acceptable		0,00
<i>No pictures to display</i>		
Centre console, Scratch(es), Acceptable		0,00
<i>No pictures to display</i>		
Internal Boot Lining L, Scratch(es), Smart repair		110,64
