**OPEL INSIGNIA SPORTS TOURER: 1JUZ129**

**Limited Technical Inspection**

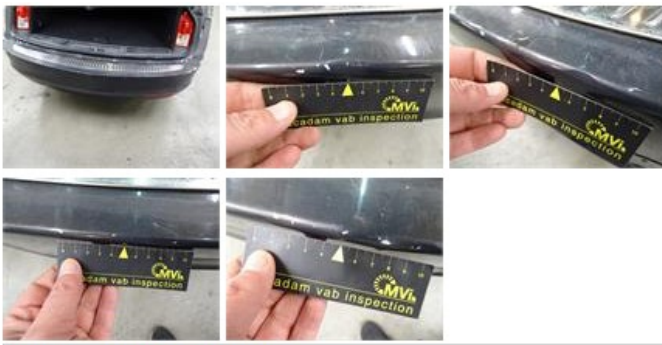
<b>Total cost ex VAT</b>	<b>676,80</b>
<b>Bumper R, Scratch(es), LI - Repair and paint (complete)</b>	<b>211,80</b>
