VOLKSWAGEN Touran: 1FU0323

Limited Technical Inspection

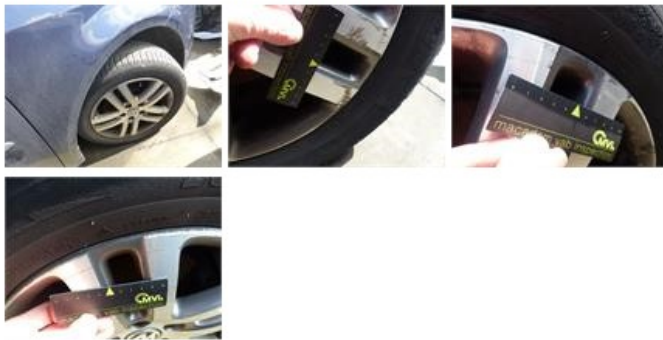
Alloy rim F R polished, Scratch(es), LI - Repair and paint (complete) 95,00

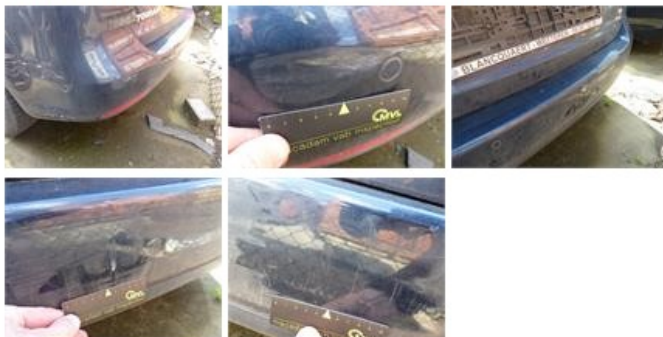
Bumper R, Scratch(es), LI - Repair and paint (complete) 211,80

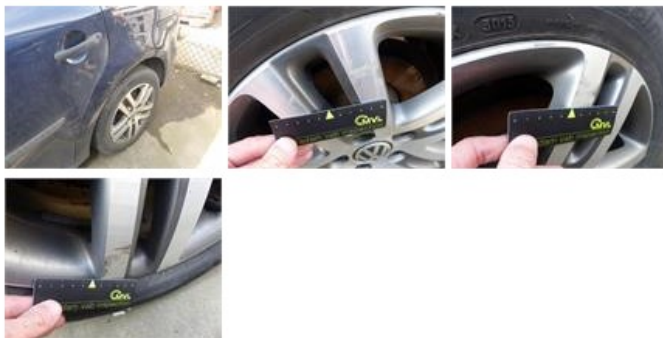
Alloy rim R L polished, Scratch(es), LI - Repair and paint (complete) 95,00

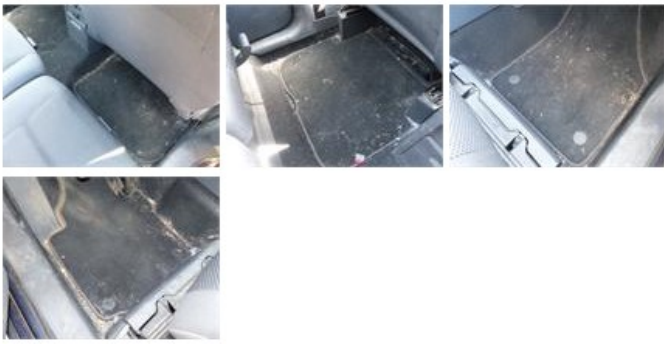
Interior, Dirty, Cleaning 30,00
