VOLKSWAGEN Golf: 1GVA815

Limited Technical Inspection

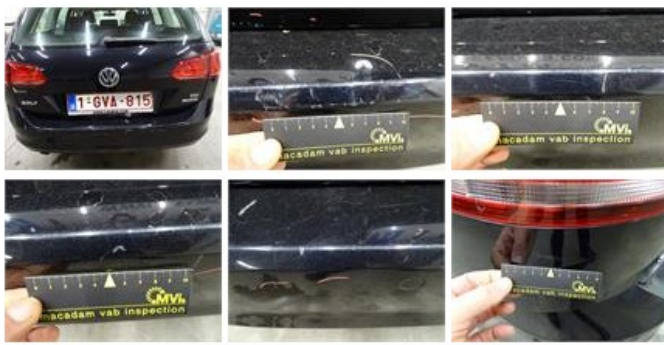
Total cost ex VAT	1648,43
Tailgate, Scratch(es), Acceptable	0,00
<i>No pictures to display</i>	
Bumper R, Scratch(es), LI - Repair and paint (complete)	211,80

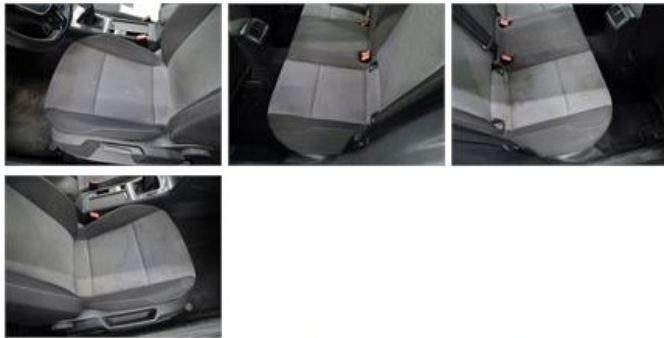
Interior, Dirty, Cleaning 0,00

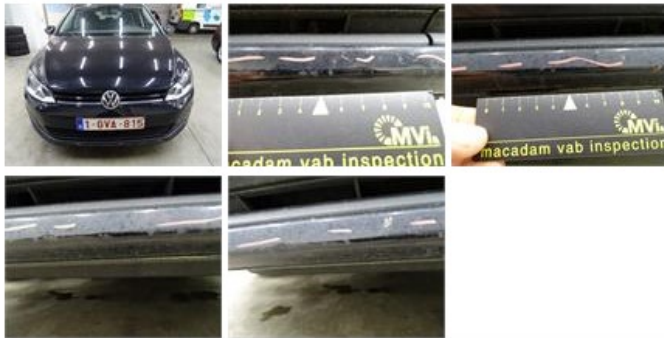
Bumper F, Dent(s) and scratch(es), LI - Repair and paint (complete) 211,80

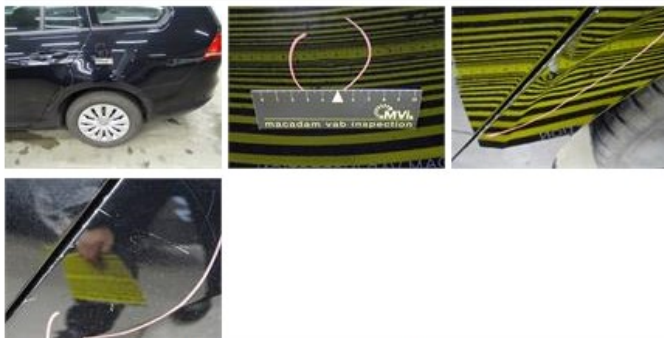
Wing R L, Dent(s) and scratch(es), LI - Repair and paint (complete) 308,20

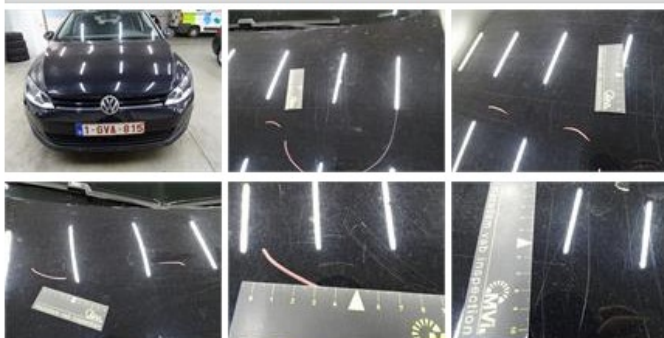
Bonnet, Scratch(es), LI - Repair and paint (complete) 290,08
