**SKODA Octavia: 1GRP448**

**Limited Technical Inspection**

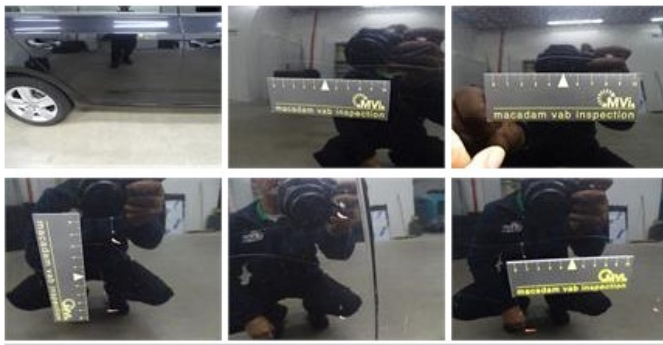
Repair kit	<b>Yes</b>	Compressor	<b>Yes</b>
Total cost ex VAT			<b>530,15</b>
Alloy rim R L, Scratch(es), Acceptable			<b>0,00</b>
<i>No pictures to display</i>			
Door R R, Scratch(es), LI - Repair and paint (complete)			<b>318,35</b>

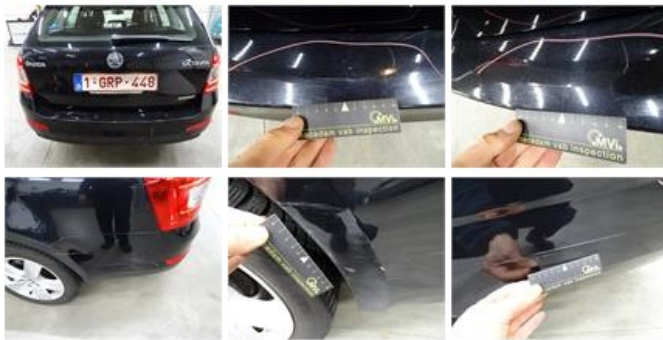
Bumper R, Dent(s) and scratch(es), LI - Repair and paint (complete) 211,80

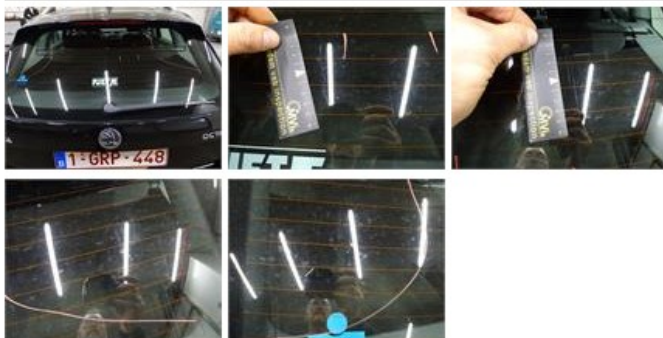
Rear window, Scratch(es), E - Replace 0,00
