**AUDI A3 SPORTBACK: 1JVK314**

**Limited Technical Inspection**

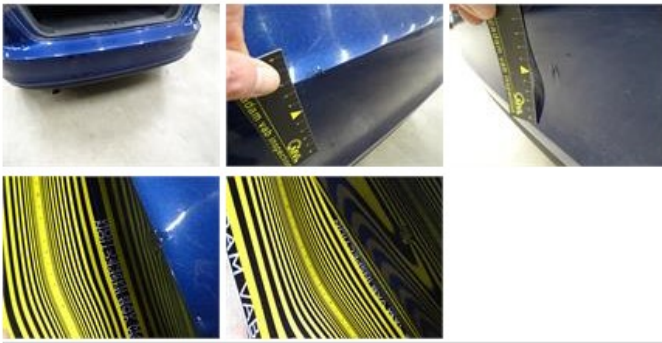
Total cost ex VAT	331,80
Bumper R, Dent(s) and scratch(es), LI - Repair and paint (complete)	211,80
