<b>BMW 3: 1FE060</b>			
Vinnumber:	<b>WBA3K11080F852568</b>	Versionname:	<b>3 TOURING 318dA 136PK Aut.</b>
First Registrationdate:	<b>7/06/2013</b>	Fiscalpower:	
Expertise Mileage:	<b>165522</b>	Power Kw:	<b>100</b>
Bodytype:	<b>Break</b>	Body color:	<b>Brown</b>
Gearbox:	<b>Automatic</b>	Paint type:	<b>Metalic</b>
Transmission:	<b>Front</b>	Rims summer:	<b>Aluminium</b>
Fueltype:	<b>Diesel</b>	Oil level:	<b>OK</b>
Battery functioning:	<b>Yes</b>	Parking lot:	<b>2427</b>
Number of doors:	<b>5</b>		
Number of seats:	<b>5</b>		
Number head rests:	<b>5</b>		
Rims summer:	<b>Aluminium</b>		
Category:	<b>Passenger Car</b>		
Oil level:	<b>OK</b>

<b>Limited Technical Inspection</b>			
Airco functioning	<b>OK</b>	Battery functioning	<b>Yes</b>
Tires wear profile	<b>OK</b>	Power steering	<b>Yes</b>
Idle position	<b>OK</b>	Sound engine	<b>OK</b>
Engine startingtime	<b>OK</b>	Clutch test	<b>OK</b>
Exhaust gass	<b>OK</b>	Wiper fluid level	<b>OK</b>
Handbrake	<b>OK</b>	Transmission	<b>OK</b>
		Lighting	<b>OK</b>
		Wiperblades	<b>OK</b>

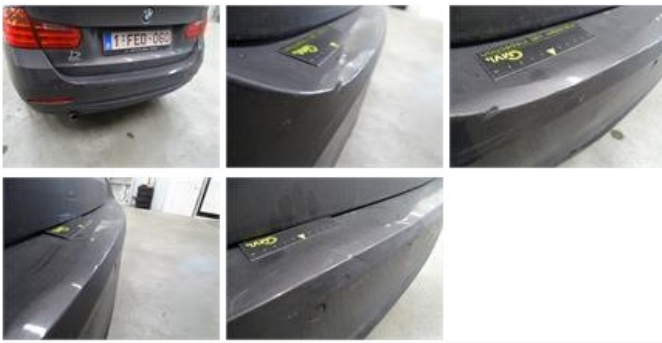
<b>Total cost ex VAT</b>	<b>2236,91</b>
<b>Bumper R, Deformed / Strained, Le - Replace and paint</b>	<b>651,00</b>

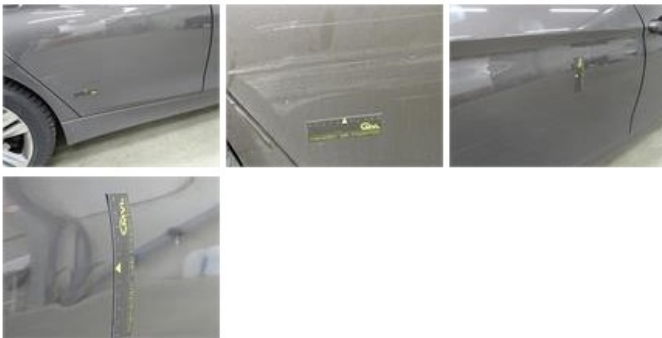
Door R R, Dent(s) and scratch(es), LI - Repair and paint (complete) 366,35

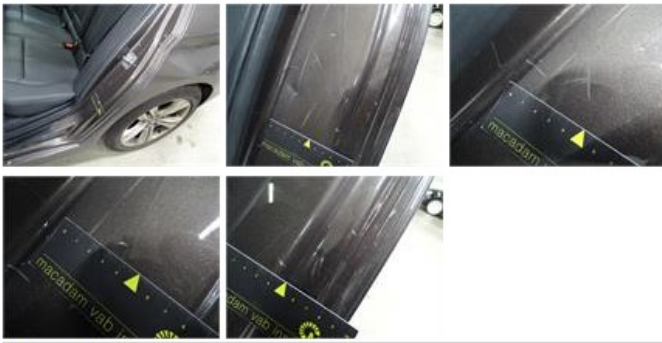
Rocker panel inner R L, Dent(s), LI - Repair and paint (complete) 115,56
