**IVECO Daily 40C15: 1BVZ466**

Vinnumber:	<b>ZCFC40A4205852908</b>	Versionname:	<b>DAILY B/F 40C15V LWB H2 146pk 3500KG</b>
First Registrationdate:	<b>16/09/2011</b>	Fiscalpower:	
Expertise Mileage:	<b>157986</b>	Power Kw:	<b>107</b>
Bodytype:	<b>Transporter</b>	Body color:	<b>White</b>
Gearbox:	<b>MAN 6 VIT</b>	Paint type:	<b>Metalic</b>
Transmission:		Rims summer:	<b>Steel</b>
Fueltype:	<b>Diesel</b>	Oil level:	<b>OK</b>
Battery functioning:	<b>Yes</b>	Parking lot:	<b>TRU17</b>
Number of doors:	<b>5</b>		
Number of seats:	<b>3</b>		
Number head rests:	<b>3</b>		
Rims summer:	<b>Steel</b>		
Category:	<b>Light Commercial Vehicle</b>		
Oil level:	<b>OK</b>		
Registration Certificate Car (BE):	<b>Yes</b>

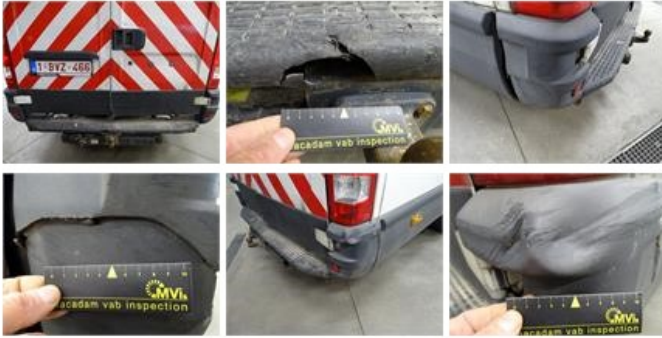
Bumper R, Deformed / Strained, E - Replace 329,40

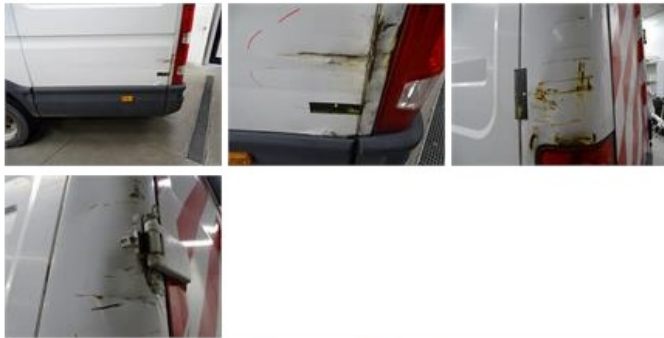
Wing R L, Dent(s) and scratch(es), LI - Repair and paint (complete)

231,15

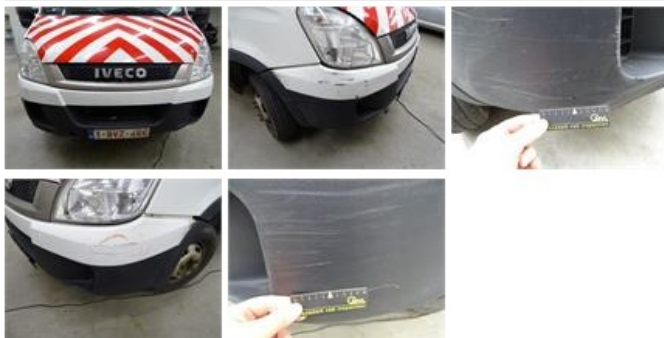
Bumper F, Scratch(es), Smart repair

110,64
