MERCEDES C: 1GGS203

Vinnumber:	WDD2040001G171532	Versionname:	C BER 180 CDI BlueEFF. S&S 120PK
First Registrationdate:	4/02/2014	Fiscalpower:	
Expertise Mileage:	196249	Power Kw:	88
Bodytype:		Body color:	Black
Gearbox:	MAN 6 VIT	Paint type:	Metallic
Transmission:		Rims summer:	Aluminium
Fueltype:	Diesel	Oil level:	OK
Battery functioning:	Yes	Parking lot:	3313
Number of doors:	4		
Number of seats:	5		
Number head rests:	5		
Rims summer:	Aluminium		
Category:	Passenger Car		
Oil level:	OK		
Registration Certificate Car (BE):	Yes

Limited Technical Inspection

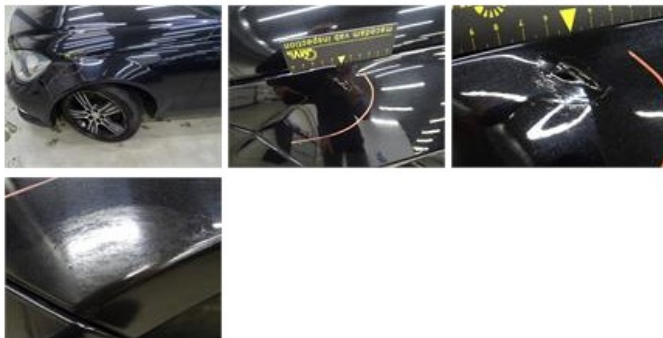
Wing F L, Dent(s) and scratch(es), LI - Repair and paint (complete)

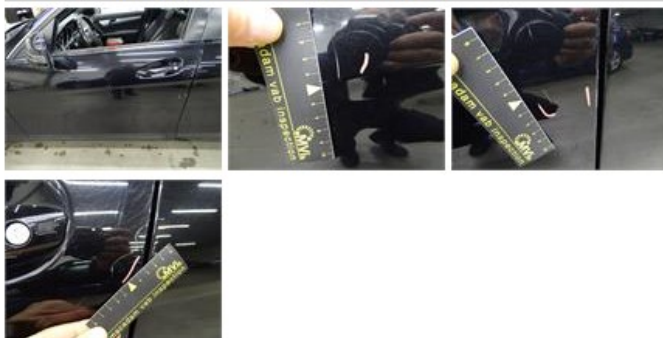
Door F L, Scratch(es), LI - Repair and paint (complete)

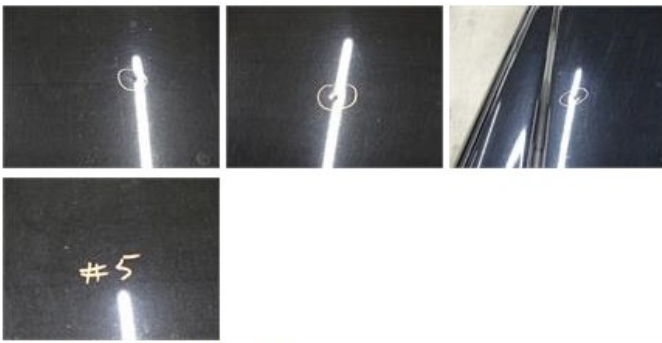
Bonnet, Dent(s), LI - Repair and paint (complete)

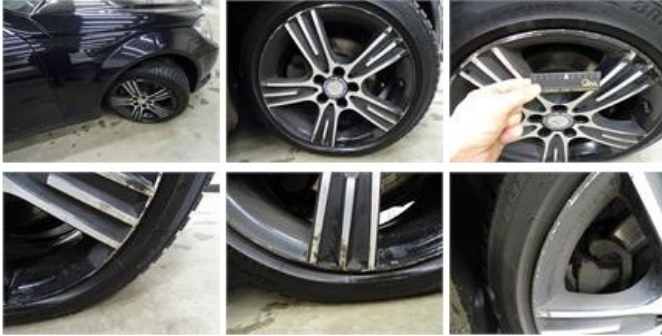
Alloy rim F R polished, Scratch(es), LI - Repair and paint (complete) 95,00

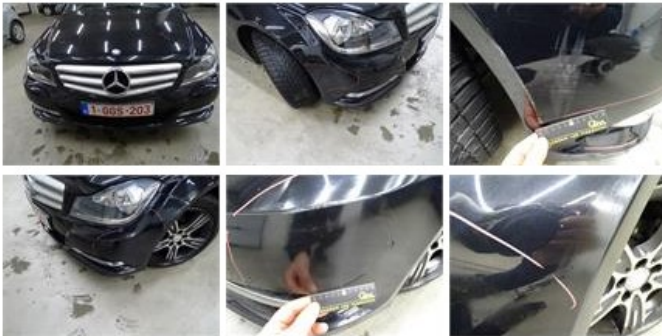
Bumper F, Scratch(es), LI - Repair and paint (complete) 290,08
