**MERCEDES A: 1FXT819**

**Limited Technical Inspection**

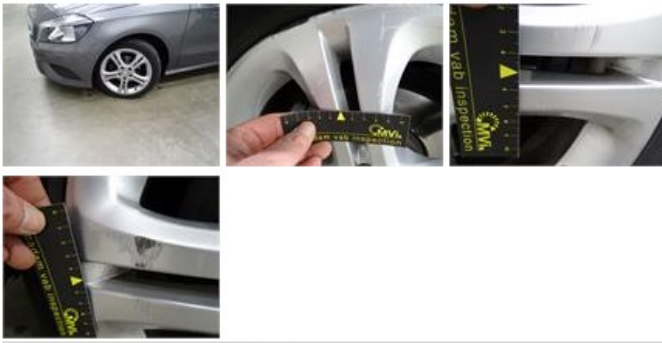
Total cost ex VAT	743,55
Alloy rim F L, Scratch(es), LI - Repair and paint (complete)	95,00
