VOLVO V40: 1HDA396

Limited Technical Inspection

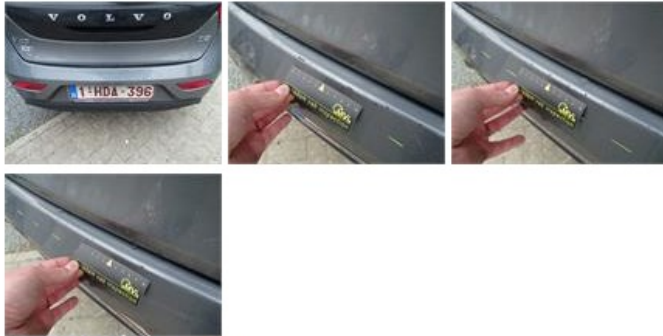
Bumper R, Scratch(es), LI - Repair and paint (complete)

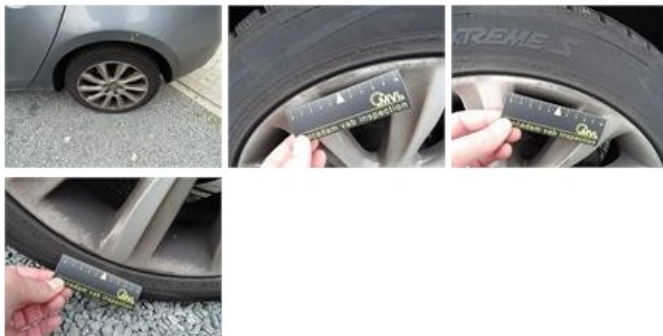
Alloy rim R L, Scratch(es), LI - Repair and paint (complete)
