VOLVO V60: 1GDJ217

Limited Technical Inspection

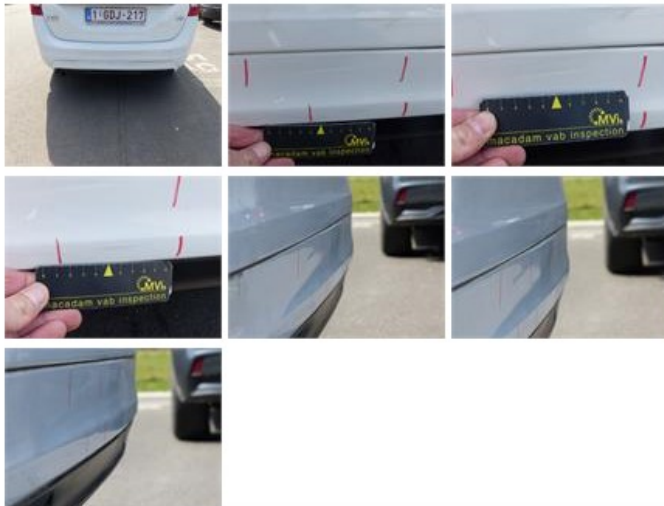
Bumper cover R M, Dent(s), Smart repair 110,64

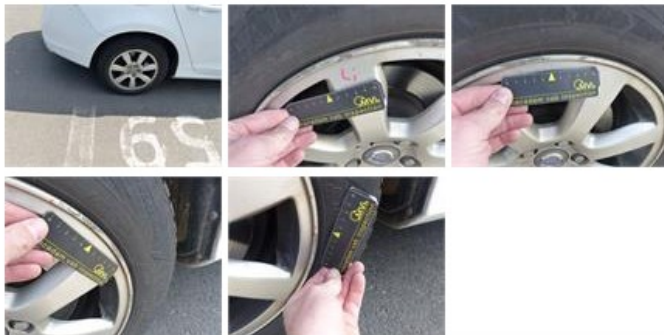
Alloy rim R R, Scratch(es), LI - Repair and paint (complete) 95,00

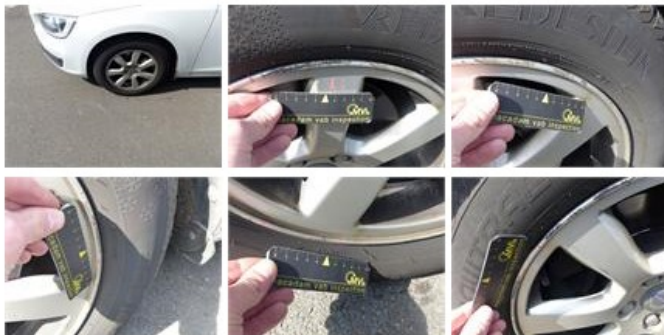
Alloy rim F L, Scratch(es), LI - Repair and paint (complete) 95,00

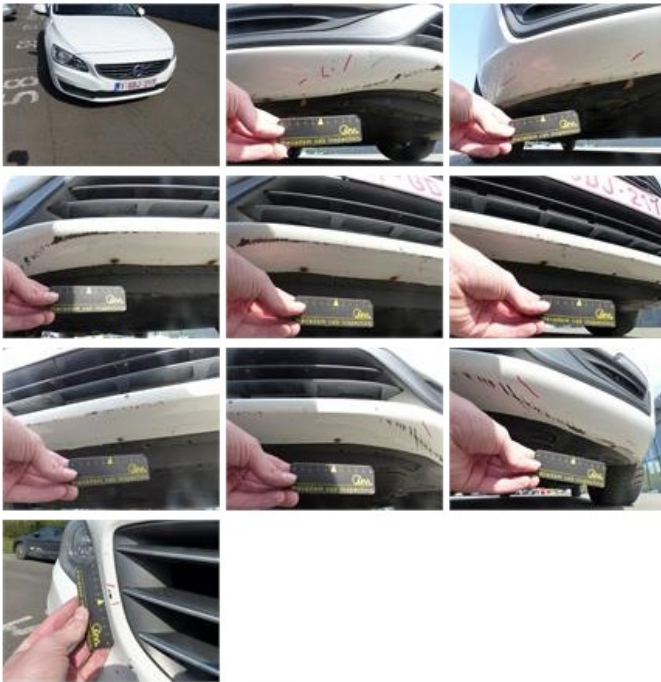
Bumper F, Scratch(es), LI - Repair and paint (complete)

211,80
