**BMW 3 GRAN TURISMO: 1JTD068**

**Limited Technical Inspection**

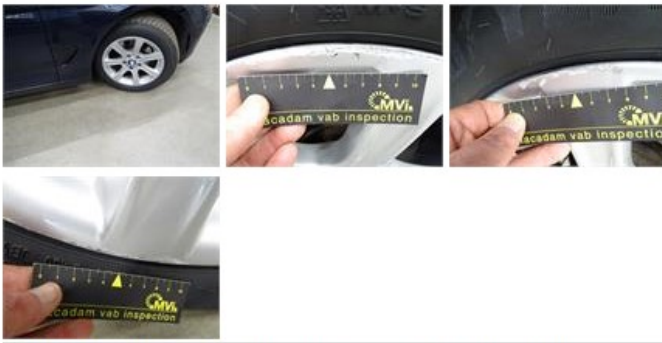
Alloy rim F R, Scratch(es), LI - Repair and paint (complete) 95,00
