**BMW 3 BERLINE: 1JXT931**

**Limited Technical Inspection**

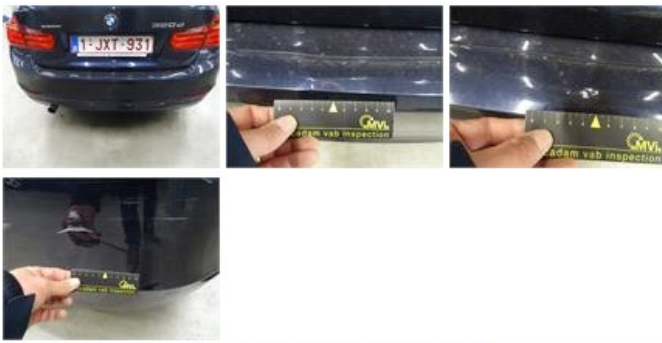
Total cost ex VAT	<b>797,58</b>
Bumper R, Dent(s) and scratch(es), LI - Repair and paint (complete)	<b>211,80</b>

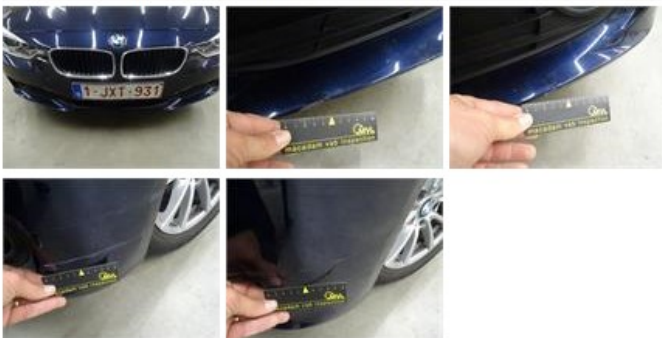
Bumper F, Dent(s) and scratch(es), LI - Repair and paint (complete) 211,80
