BMW SERIE 3 TOURING: 1HXP033

Vinnumber:	WBA3K91080F936453	Versionname:	316D
First Registrationdate:	22/10/2014	Fiscalpower:	
Expertise Mileage:	115314	Power Kw:	85
Bodytype:		Body color:	Black
Gearbox:	MAN 6 VIT	Paint type:	Metallic
Transmission:	Back	Rims summer:	Aluminium
Fueltype:	Diesel	Oil level:	OK
Maintenance:	IN 3600 KM	Parking lot:	3414
Maintenance:	OK		
Battery functioning:	Yes		
Number of doors:	5		
Number of seats:	5		
Number head rests:	5		
Rims summer:	Aluminium		
Category:	Passenger Car		
Oil level:	OK		
Registration Certificate Car (BE):	Yes

Limited Technical Inspection

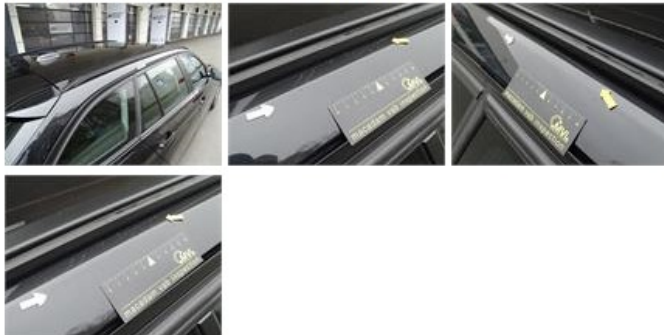
Roof pillar R, Scratch(es), LI - Repair and paint (complete)

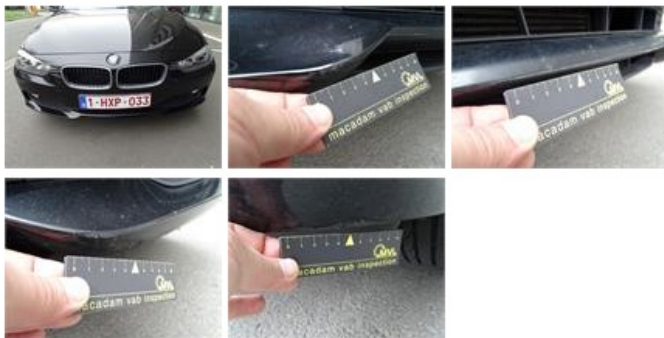
Bumper F, Scratch(es), LI - Repair and paint (complete)

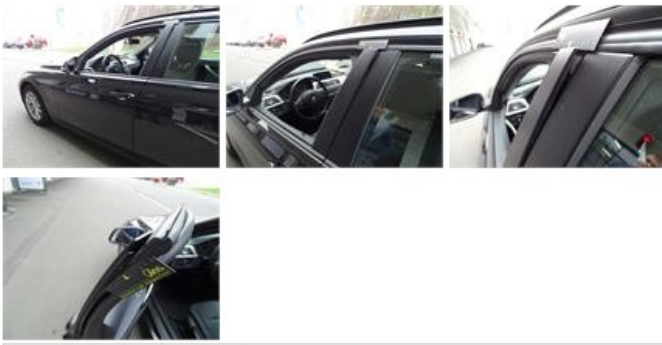
Door F L, Deformed / Strained, LI - Repair and paint (complete)

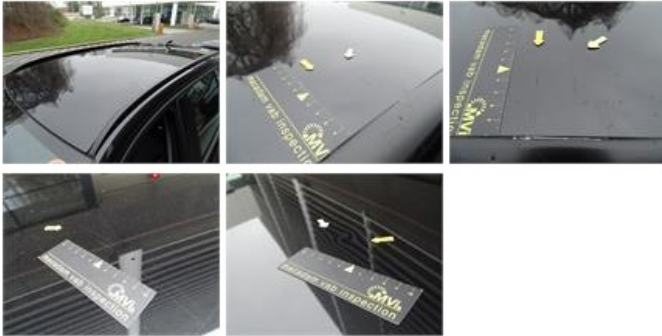
Roof, Dent(s) and scratch(es), LI - Repair and paint (complete) 529,50

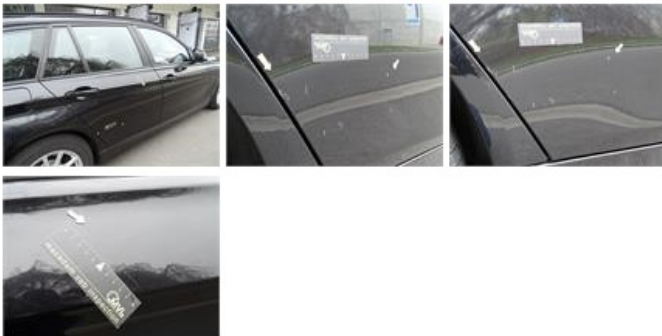
Door R R, Scratch(es), LI - Repair and paint (complete) 318,35

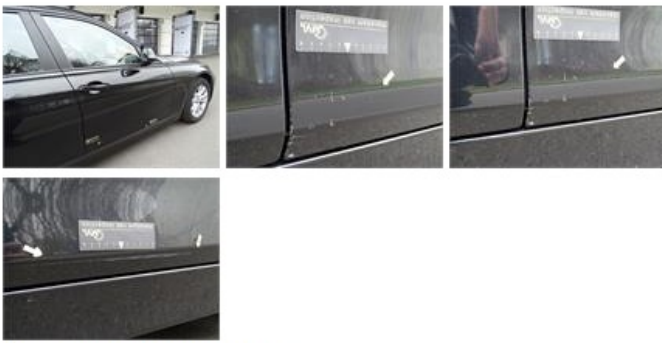
Door F R, Scratch(es), LI - Repair and paint (complete) 318,35

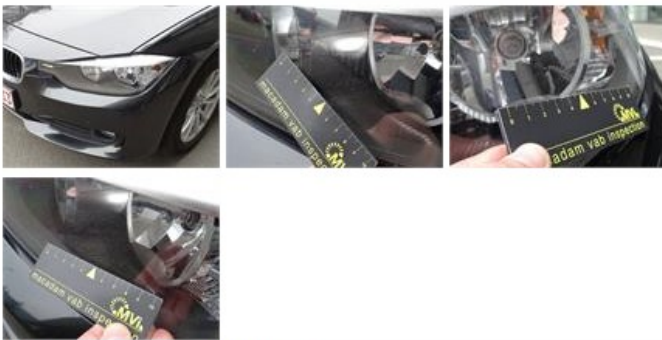
Headlight L, Scratch(es), E - Replace 396,00

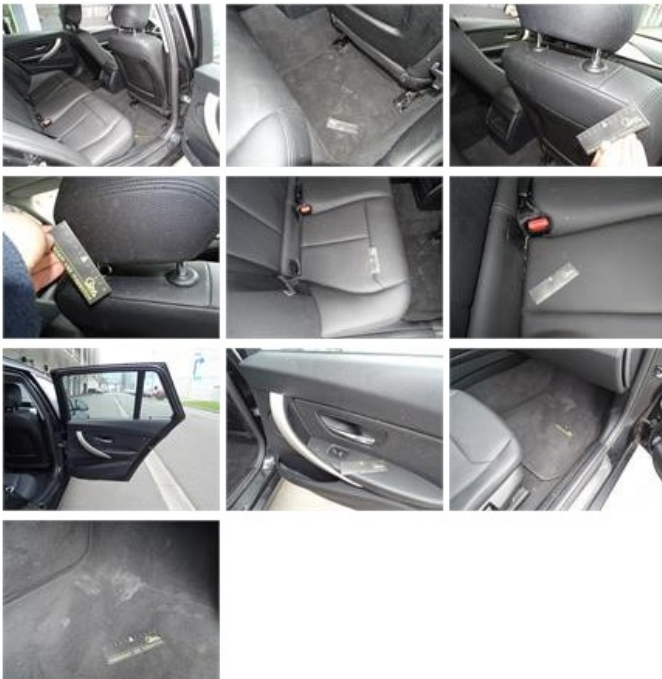
Interior, Dirty, Cleaning 152,58
