MERCEDES GLA: 1HZU590

| Vinnnumber: | WDC1569081J060661 | Versionname: | GLA 200 CDI 136PK |

Limited Technical Inspection

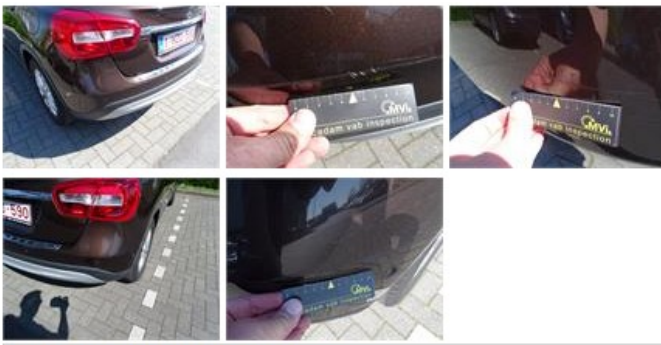
| Bumper R, Scratch(es), LI - Repair and paint (complete) | 211,80 |
