VOLKSWAGEN Golf: 1ERM202

Limited Technical Inspection

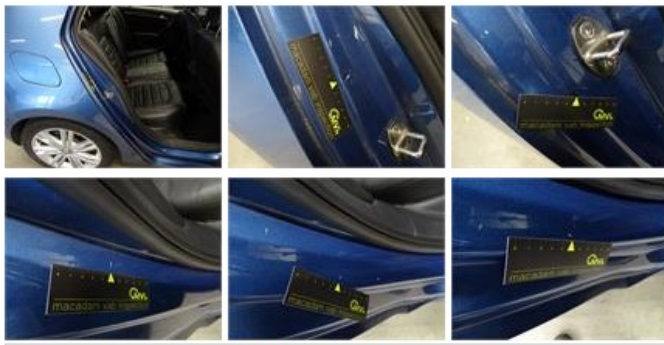
Total cost ex VAT	3193,78
Rocker panel inner R R, Dent(s), LI - Repair and paint (complete)	115,56

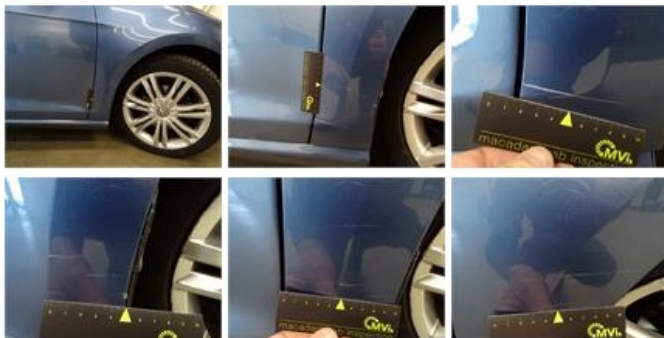
Wing F R, Scratch(es), LI - Repair and paint (complete)

220,18

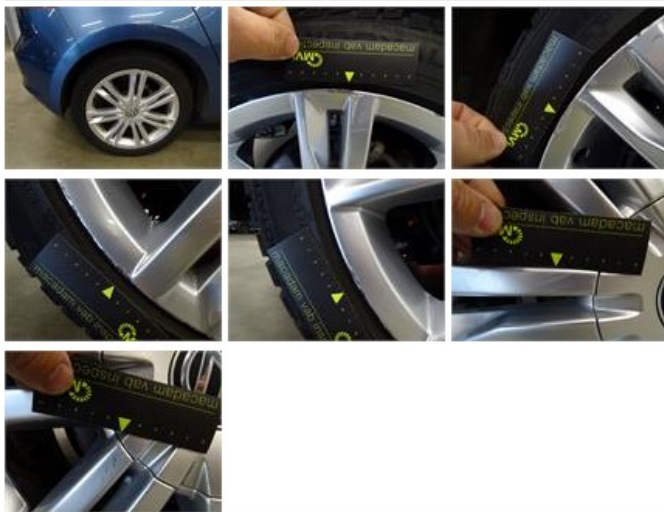
Alloy rim R R, Scratch(es), LI - Repair and paint (complete)

95,00

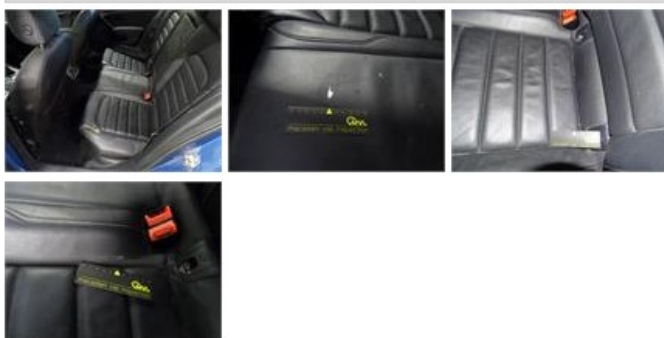
Seat cover R, Stain, Cleaning

25,00

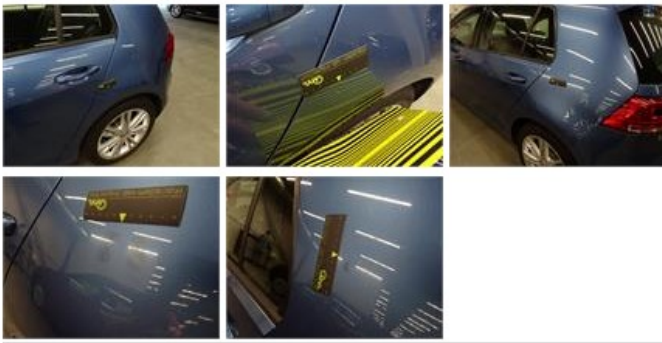
Wing R L, Dent(s) and scratch(es), LI - Repair and paint (complete)

308,20

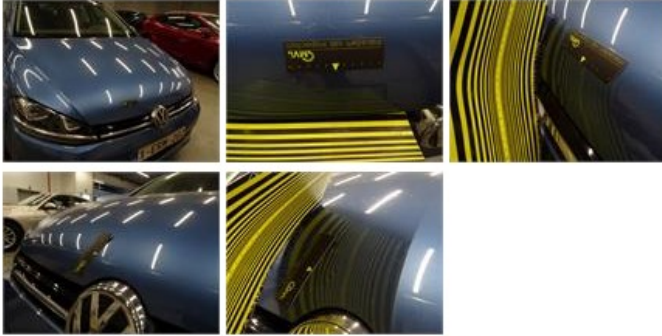
Bonnet, Dent(s), LI - Repair and paint (complete)

386,08

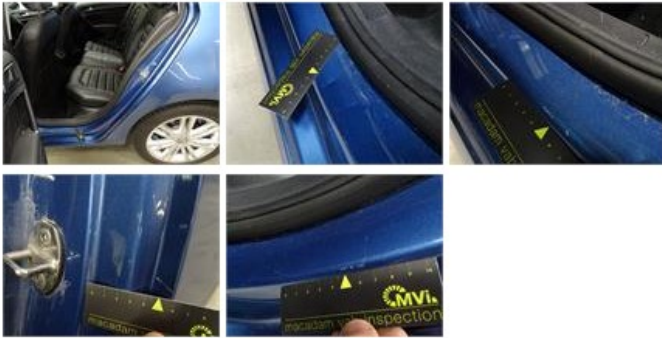
Rocker panel inner R L, Dent(s), LI - Repair and paint (complete)

115,56

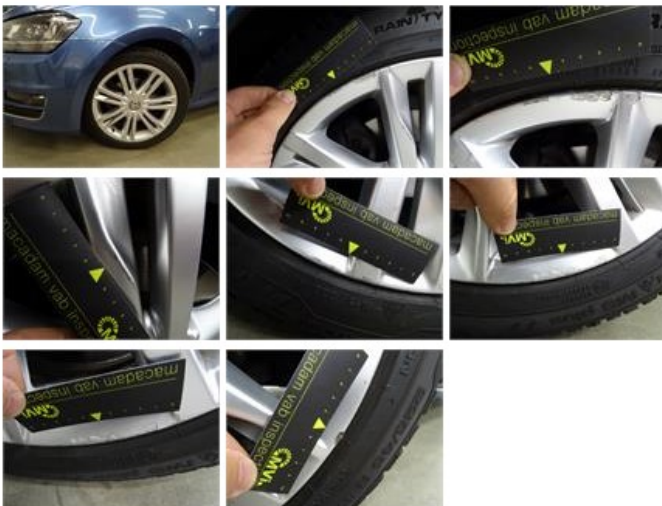
Alloy rim F L, Scratch(es), LI - Repair and paint (complete)

95,00

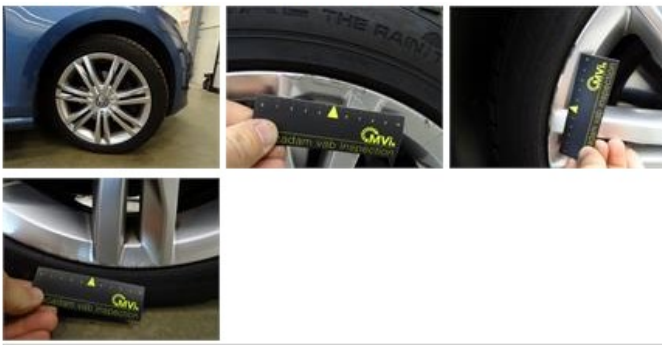
Alloy rim F R, Scratch(es), LI - Repair and paint (complete)

95,00

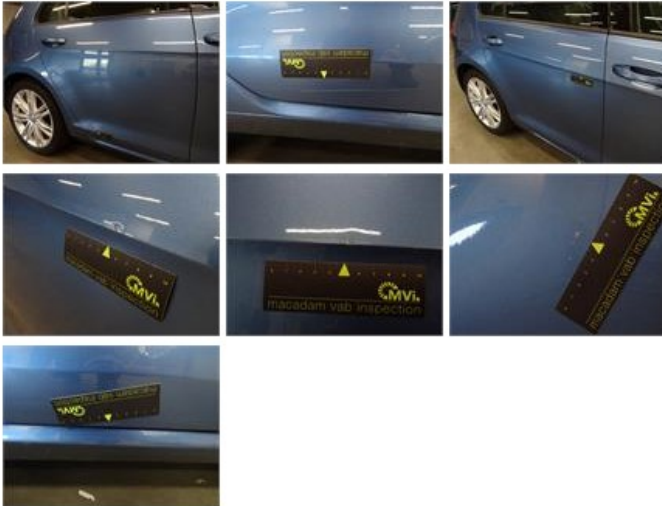
Door R R, Dent(s) and scratch(es), LI - Repair and paint (complete) 318,35

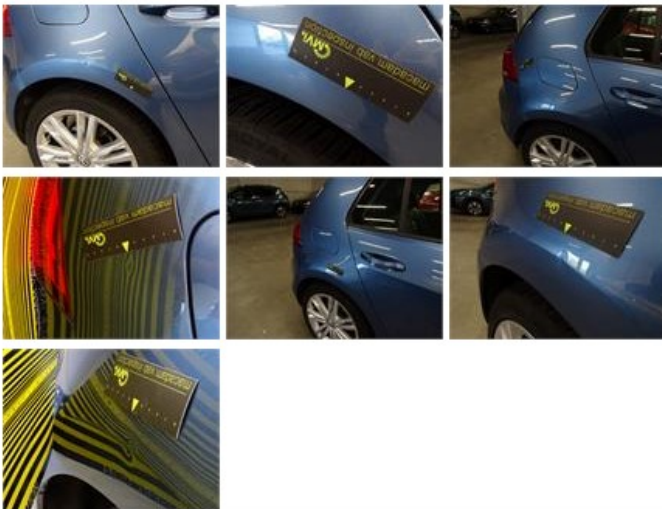
Wing R R, Dent(s) and scratch(es), LI - Repair and paint (complete) 308,20

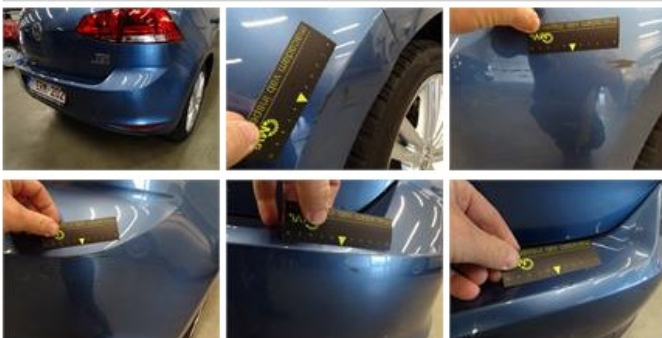
Bumper R, Scratch(es), LI - Repair and paint (complete) 211,80
