RENAULT KANGOO EXPRESS: 1KDZ095

Limited Technical Inspection

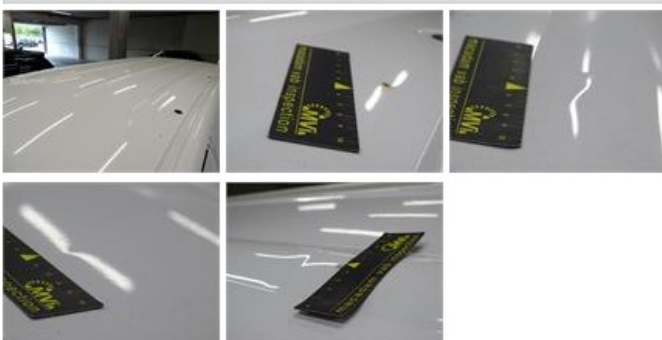
Roof, Dent(s), LI - Repair and paint (complete) 361,13
