PEUGEOT 308 SW: 1KET264

Limited Technical Inspection

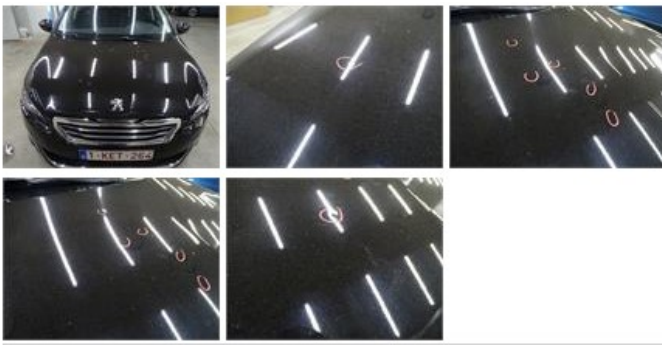
Bonnet, Hail damage, PDR - Hail	0,00
---------------------------------	-------------

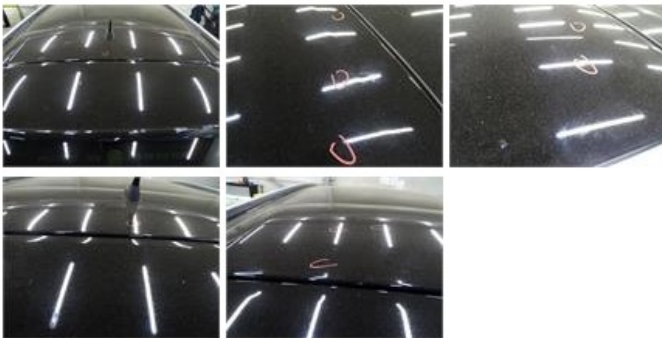
Roof, Hail damage, PDR - Hail 0,00
