**BMW 5: 1WDA494**

**Limited Technical Inspection**

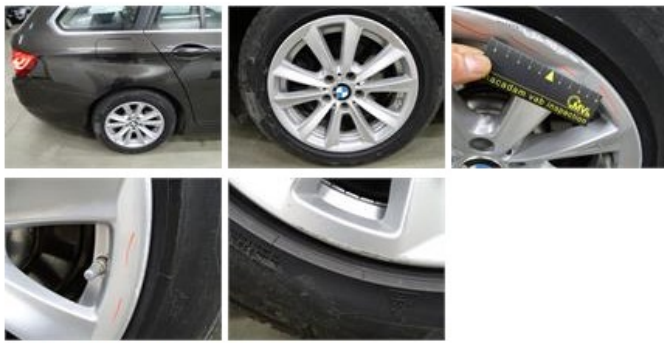
| Alloy rim R R, Scratch(es), LI - Repair and paint (complete) | | | <b>95,00</b> |

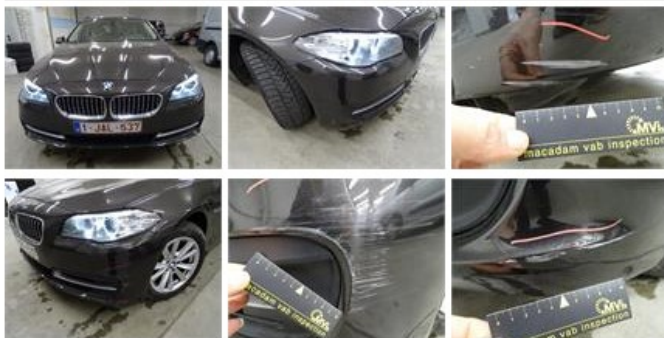
Bumper F, Scratch(es), LI - Repair and paint (complete) 254,16

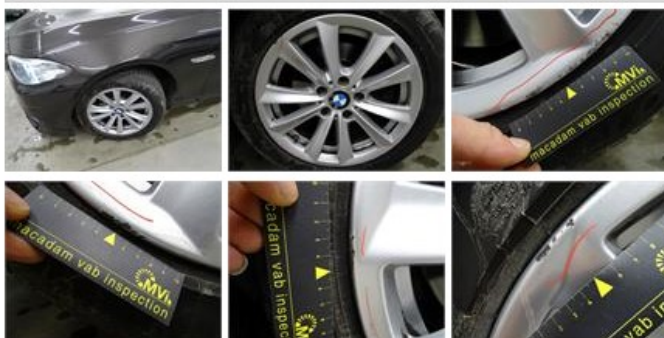
Alloy rim F L, Scratch(es), LI - Repair and paint (complete) 95,00

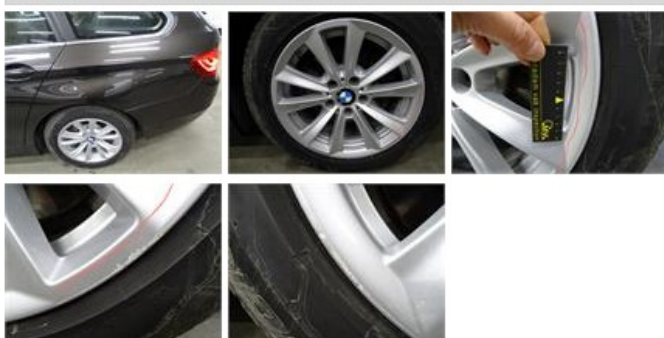
Alloy rim R L, Scratch(es), LI - Repair and paint (complete) 95,00

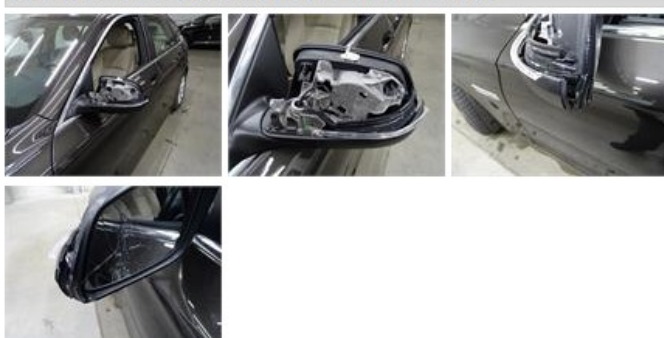
Rearview mirror L complete, Broken, Le - Replace and paint 307,00
