**NISSAN Qashqai: 1GTK339**

**Limited Technical Inspection**

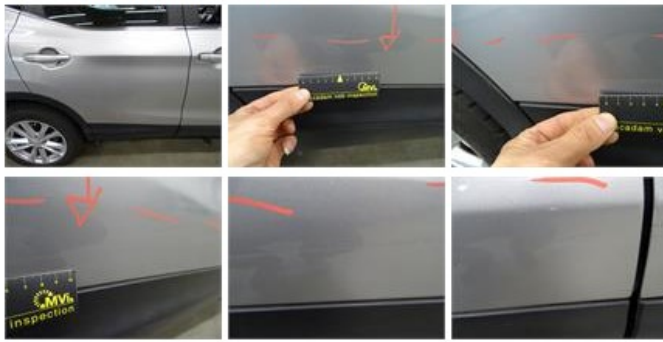
Door R R, Scratch(es), LI - Repair and paint (complete)

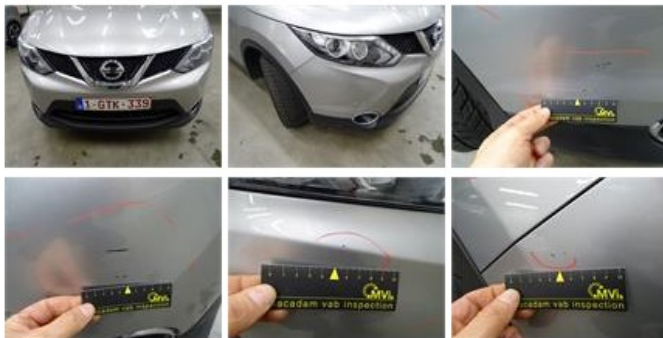
Bumper F, Scratch(es), LI - Repair and paint (complete)

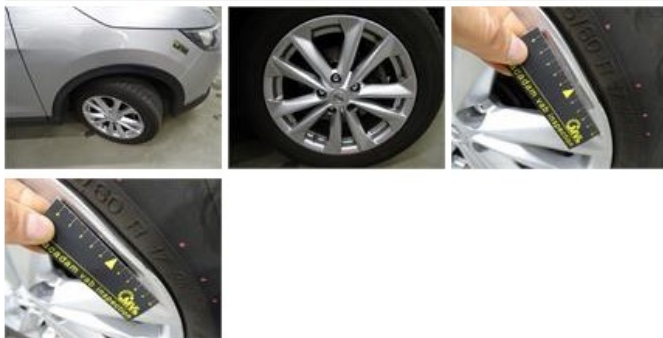
Alloy rim F R, Deformed / Strained, E - Replace

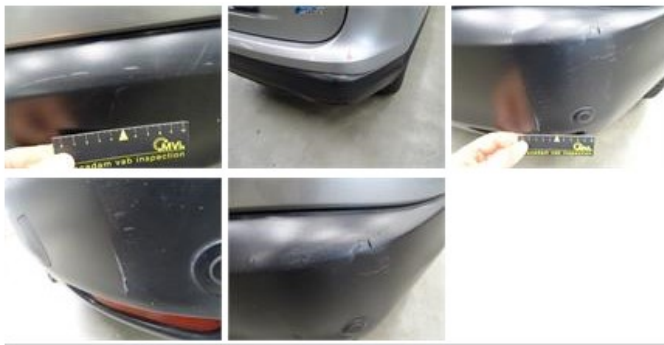
Bumper R, Dent(s) and scratch(es), Smart repair

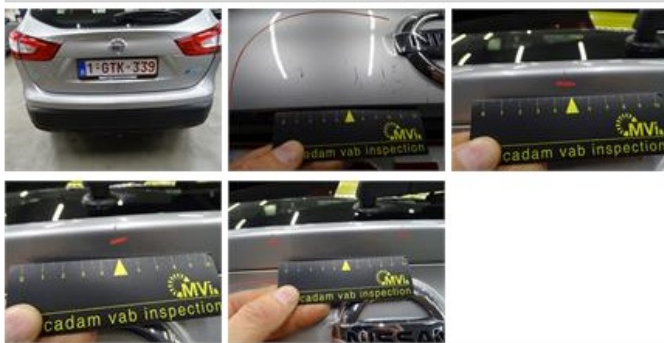
Tailgate, Scratch(es), LI - Repair and paint (complete) 301,68

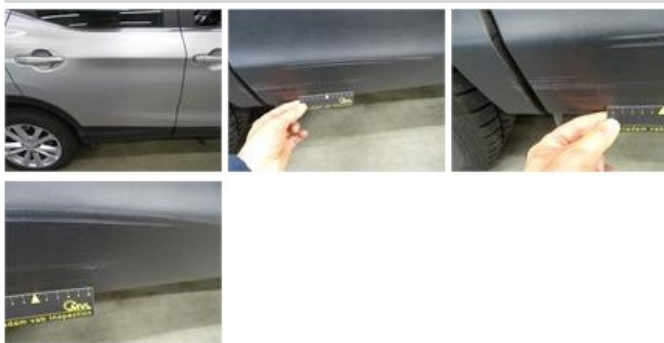
Door moulding Lower R R, Scratch(es), E - Replace 0,00
