## VOLVO V40: 1JUR212

## Limited Technical Inspection

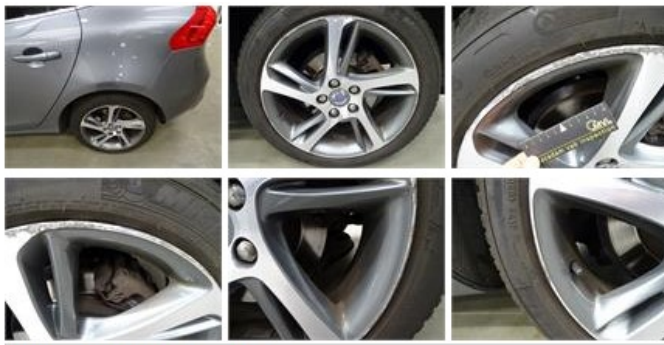
Repair kit	<b>Yes</b>	Compressor	<b>Yes</b>
Total cost ex VAT			<b>1155,12</b>
Alloy rim R L polished, Scratch(es), E - Replace			<b>235,20</b>

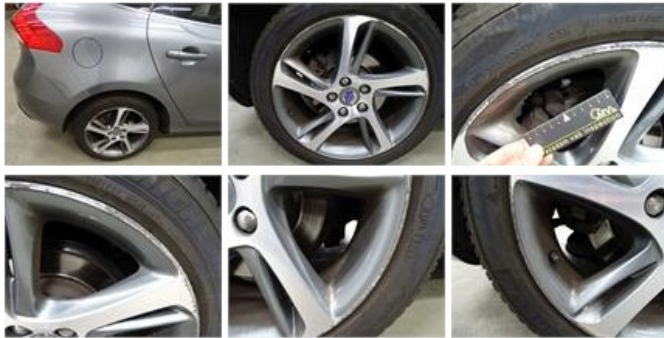
Alloy rim R R polished, Scratch(es), E - Replace 235,20

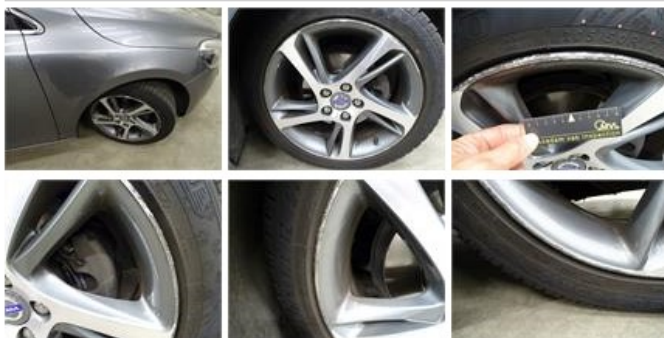
Alloy rim F R polished, Scratch(es), E - Replace 235,20

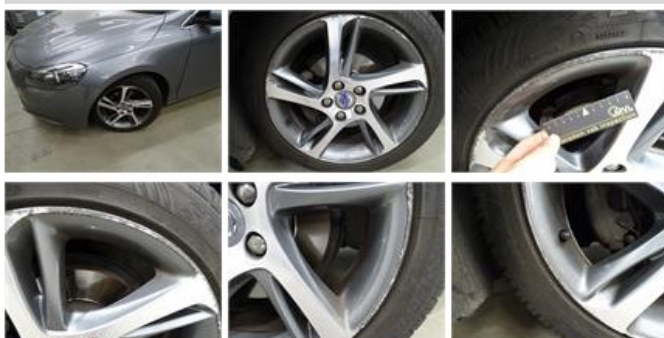
Alloy rim F L polished, Scratch(es), E - Replace 235,20
