**VOLVO V70: 1JVK091**

**Limited Technical Inspection**

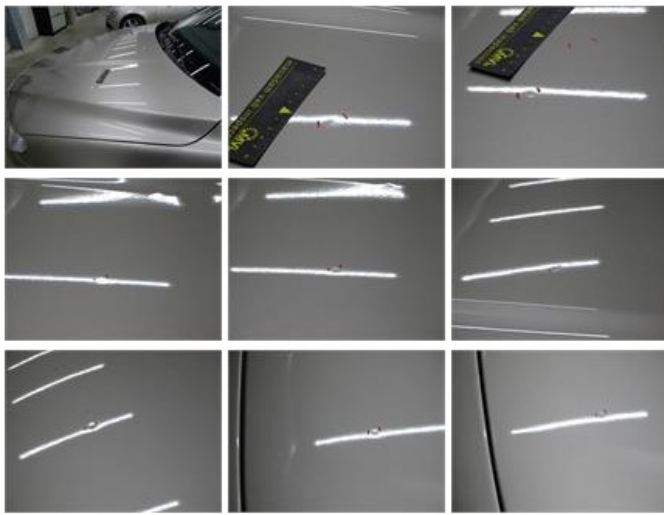
Total cost ex VAT	<b>1512,05</b>
Bonnet, Hail damage, LI - Repair and paint (complete)	<b>348,09</b>

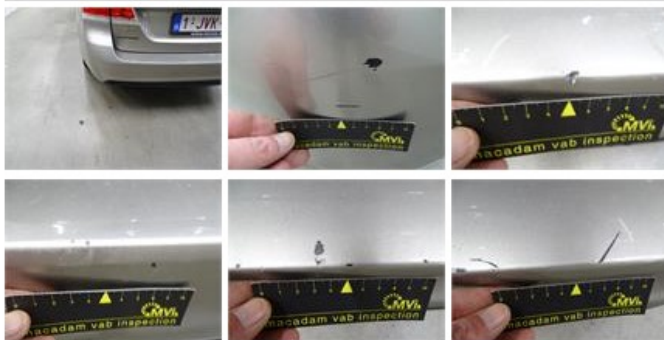
Bumper R, Scratch(es), LI - Repair and paint (complete)
