PEUGEOT 508: 1GS110

Limited Technical Inspection

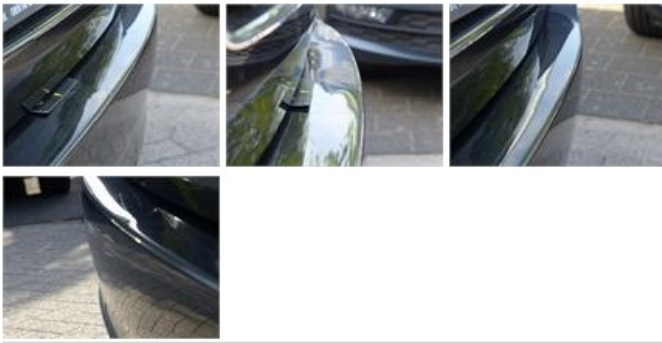
Bumper R, Dent(s) and scratch(es), LI - Repair and paint (complete)	259,80
---	--------
