AUDI A3 SPORTBACK: 1JVR332

Limited Technical Inspection

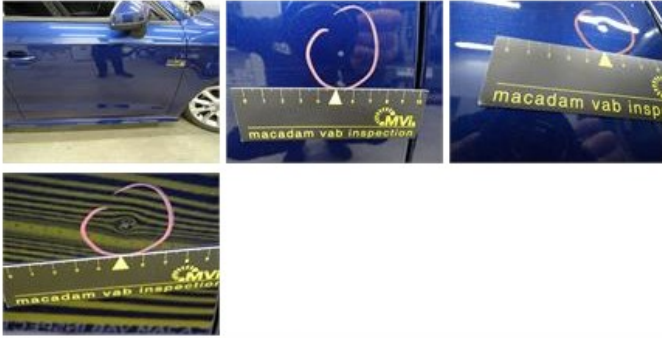
Door F R, Dent(s) and scratch(es), LI - Repair and paint (complete) 318,35

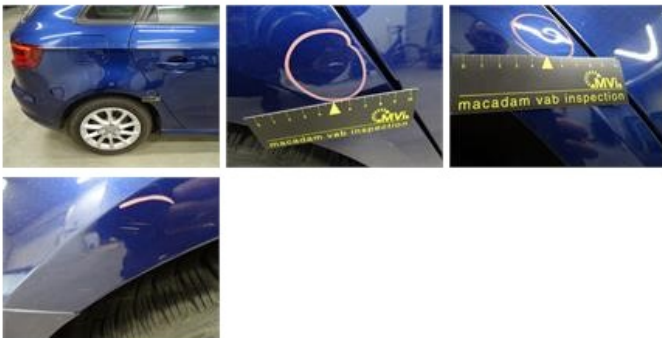
Wing R R, Dent(s) and scratch(es), LI - Repair and paint (complete) 308,20

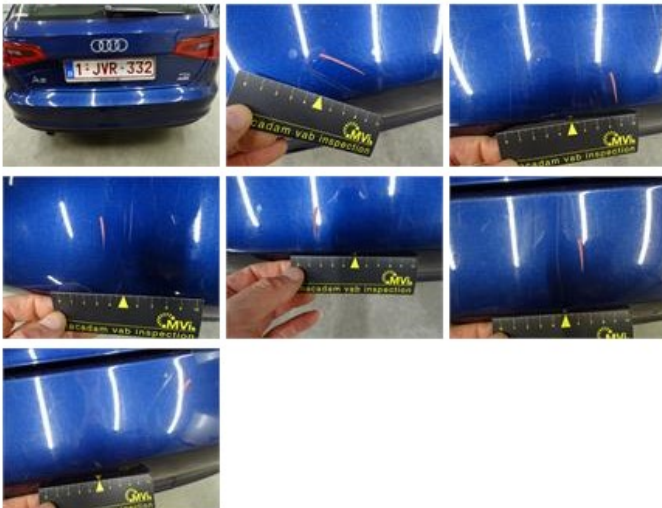
Bumper R, Scratch(es), LI - Repair and paint (complete) 211,80
