**BMW 2 Active Tourer: 1JAL523**

**Limited Technical Inspection**

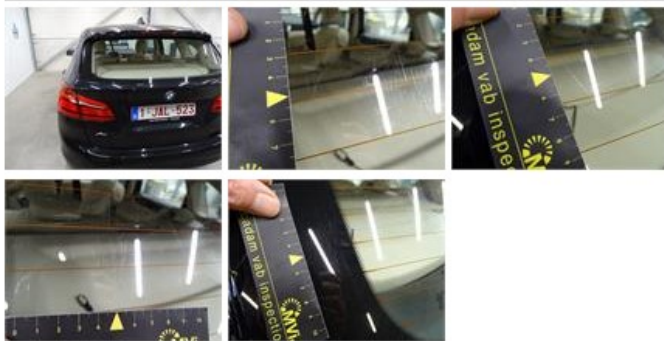
Rear window, Scratch(es), E - Replace

370,00
