**BMW 5: 1GTA543**

**Limited Technical Inspection**

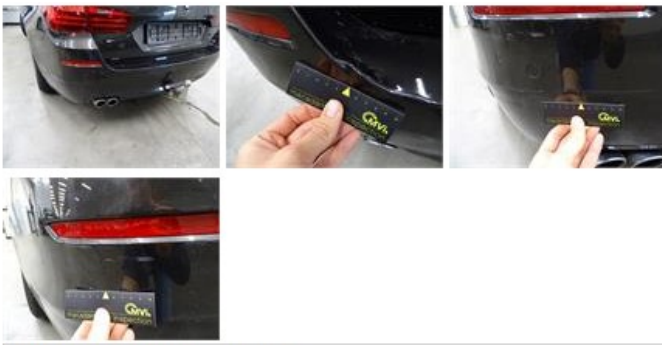
<b>Total cost ex VAT</b>	<b>1515,16</b>
<b>Bumper R, Deformed / Strained, LI - Repair and paint (complete)</b>	<b>350,16</b>

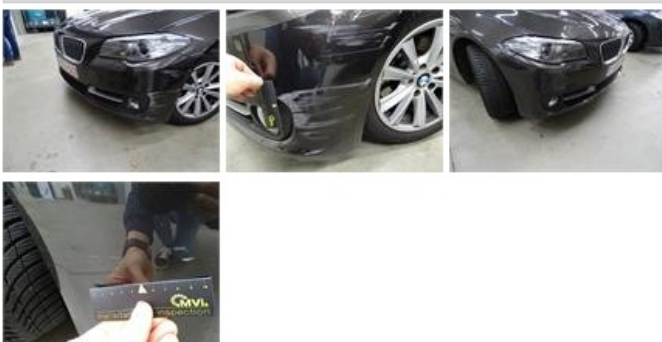
Bumper F, Scratch(es), LI - Repair and paint (complete) 254,16
