KIA Cee'd: 1GTU775

Limited Technical Inspection

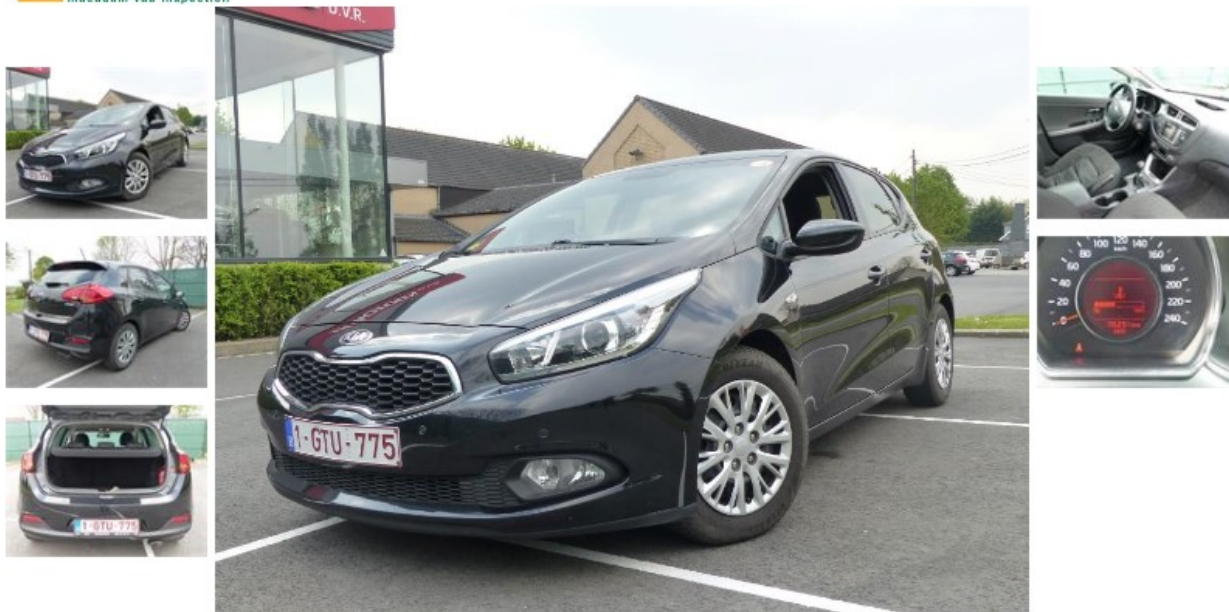
Vinnumber:	USYHM516AEL135861	Versionname:	CEE'D BER Business Line '2' ISG 110PK
First Registrationdate:	28/04/2014	Fiscalpower:	
Expertise Mileage:	78291	Power Kw:	81
Bodytype:		Body color:	Black
Gearbox:	MAN 6 VIT	Paint type:	Metalic
Transmission:	Front	Rims summer:	Steel
Fueltype:	Diesel	Oil level:	OK
Maintenance:	293 JOURS	Parking lot:	2332
Maintenance:	OK		
Maintenance:	10250		
Battery functioning:	Yes		
Number of doors:	5		
Number of seats:	5		
Number head rests:	5		
Rims summer:	Steel		
Category:	Passenger Car		
Oil level:	OK		
Registration Certificate Car (BE):	Yes
