**SKODA Superb: 1GKH113**

**Limited Technical Inspection**

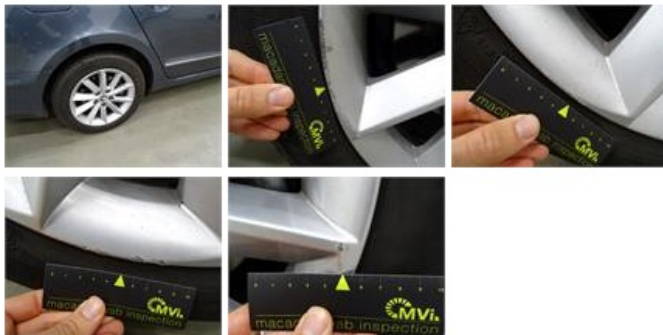
Alloy rim R R, Scratch(es), LI - Repair and paint (complete)

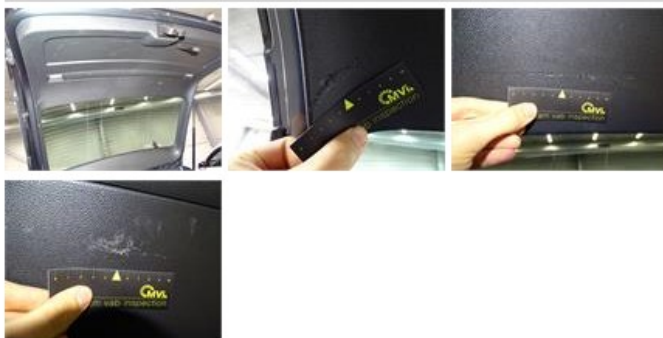
Trunk lid covering R, Scratch(es), E - Replace

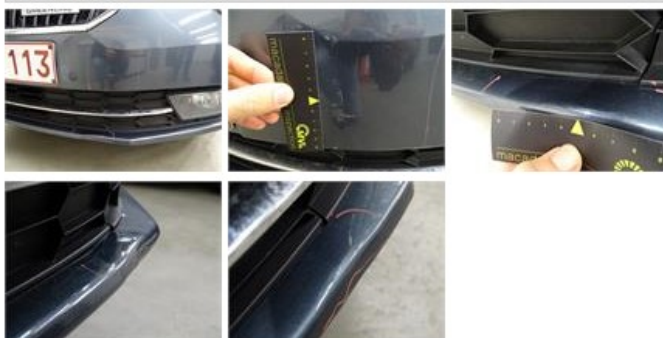
Bumper F, Dent(s) and scratch(es), LI - Repair and paint (complete)
