OPEL Movano 3500 MWB Med.High Roof: 1GDH575

Limited Technical Inspection

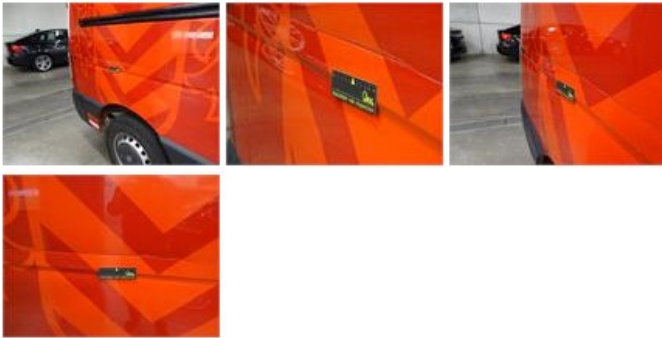
Wing R R, Dent(s) and scratch(es), LI - Repair and paint (complete) 327,15

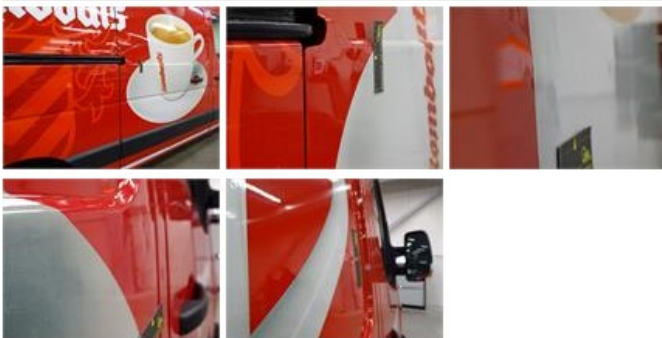
Sliding door R, Dent(s), LI - Repair and paint (complete) 382,02

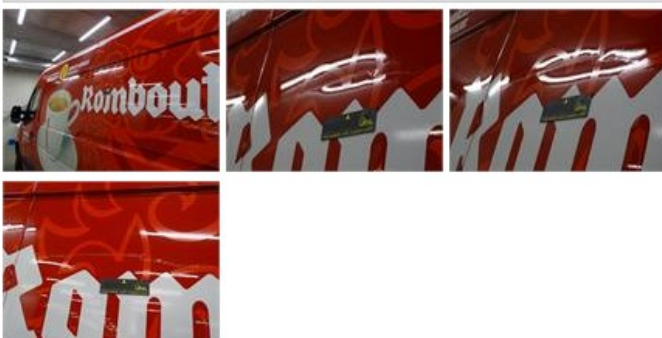
Wing R L, Dent(s) and scratch(es), LI - Repair and paint (complete) 231,15

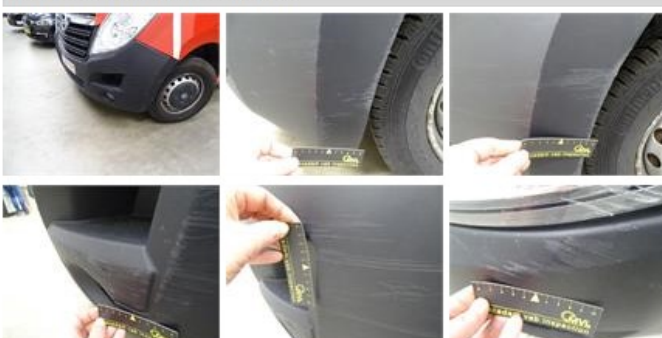
Bumper F, Scratch(es), E - Replace 398,40
