**TOYOTA Grand Prius Plus: 1ESB684**

**Limited Technical Inspection**

**Degree of wear**

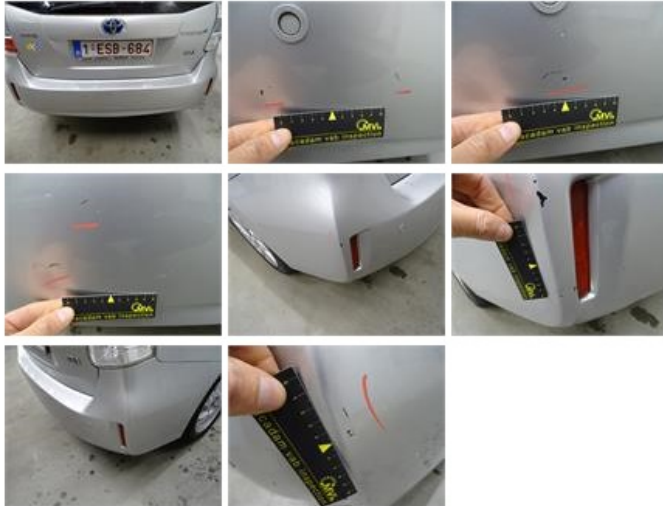
Bumper R, Scratch(es), LI - Repair and paint (complete)

211,80
