**VOLVO V60: 1KET275**

**Limited Technical Inspection**

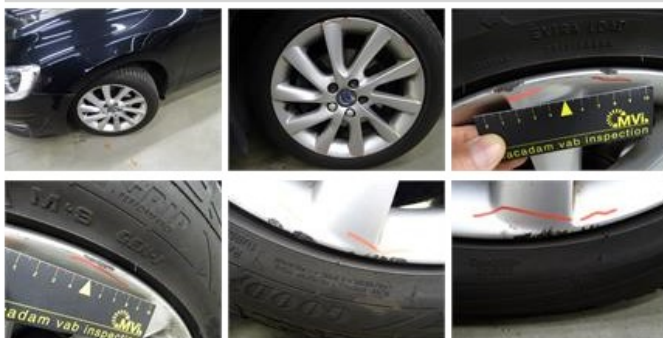
Alloy rim F L, Scratch(es), LI - Repair and paint (complete)

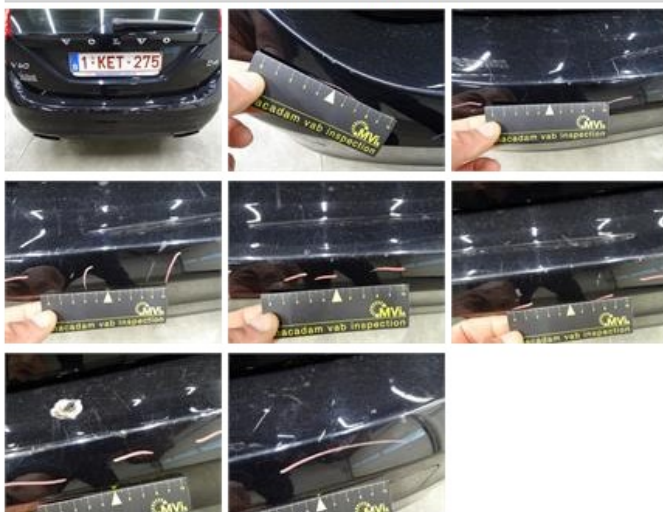
Bumper R, Scratch(es), LI - Repair and paint (complete)

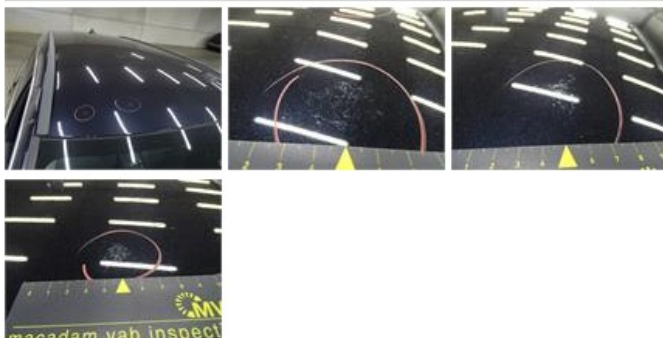
Roof, Chemical pollution, LI - Repair and paint (complete)

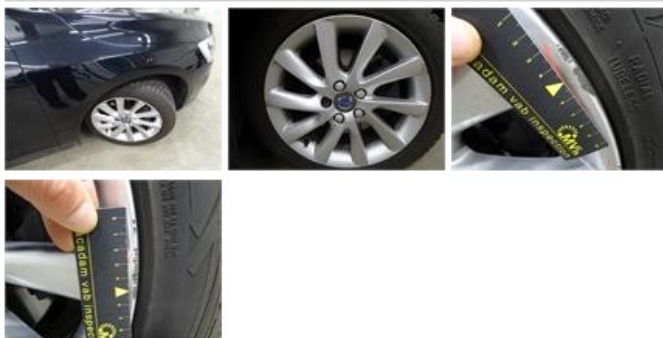
Alloy rim F R, Scratch(es), LI - Repair and paint (complete)
