**BMW 1 HATCH: 1RJ1538**

**Limited Technical Inspection**

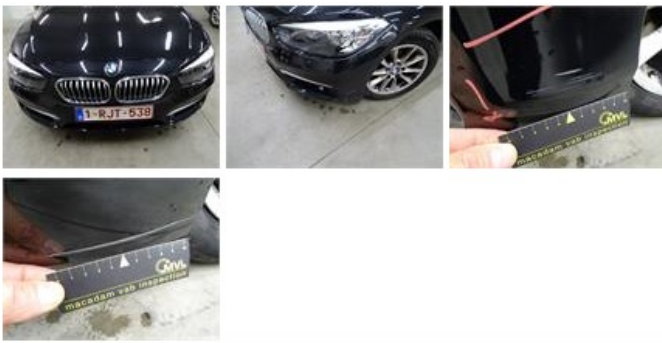
Total cost ex VAT	<b>643,78</b>
Door F L, Scratch(es), Acceptable	<b>0,00</b>
<i>No pictures to display</i>	
Bumper F, Scratch(es), LI - Repair and paint (complete)	<b>211,80</b>

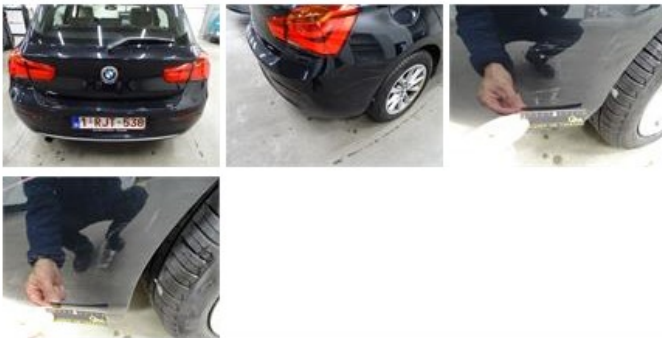
Bumper R, Scratch(es), LI - Repair and paint (complete) 211,80
