**CITROEN C4 Picasso: 1GVQ879**

**Limited Technical Inspection**

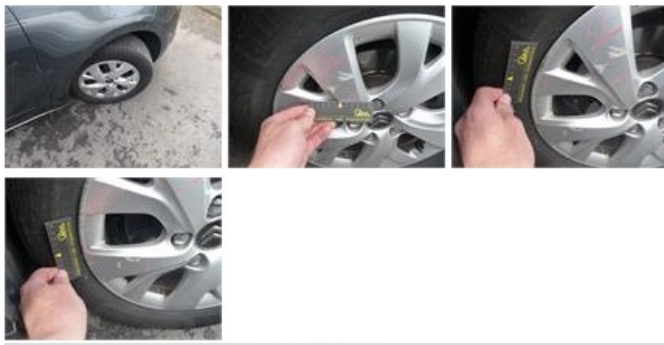
Total cost ex VAT		210,56
Alloy rim F R, Scratch(es), LI - Repair and paint (complete)		95,00

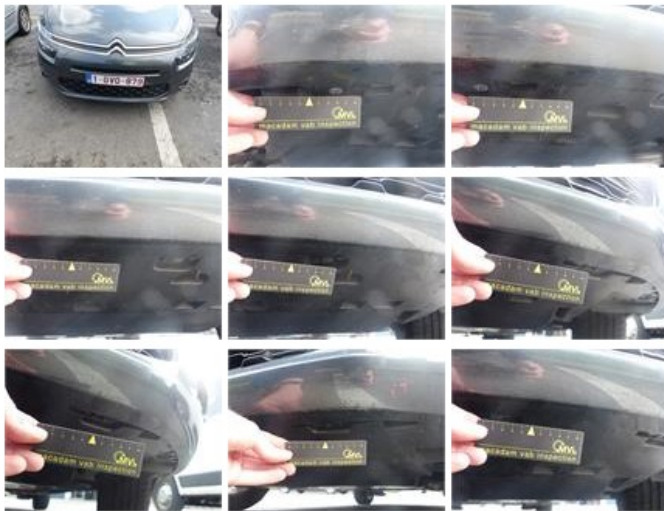
Door R L, Dent(s) and scratch(es), Acceptable	0,00
<i>No pictures to display</i>	
Bumper R, Scratch(es), Acceptable	0,00
<i>No pictures to display</i>	
Door F L, Dent(s) and scratch(es), Acceptable	0,00
<i>No pictures to display</i>	
Alloy rim R R, Scratch(es), Acceptable	0,00
<i>No pictures to display</i>	
Bumper F, Scratch(es), It - Spot repair	115,56
