PEUGEOT 2008: 1HLF977

Vinnumber:	VF3CU9HP0EY085944	Versionname:	2008 e-HDi Allure 92PK
First Registrationdate:	19/08/2014	Fiscalpower:	
Expertise Mileage:	84460	Power Kw:	68
Bodytype:	SUV	Body color:	Grey
Gearbox:	MAN 5 VIT	Paint type:	Metallic
Transmission:	Front	Rims summer:	Aluminium
Fueltype:	Diesel	Oil level:	OK
Battery functioning:	Yes	Parking lot:	3125
Number of doors:	5		
Number of seats:	5		
Number head rests:	5		
Rims summer:	Aluminium		
Category:	Passenger Car		
Oil level:	OK		
Registration Certificate Car (BE):	Yes

Limited Technical Inspection

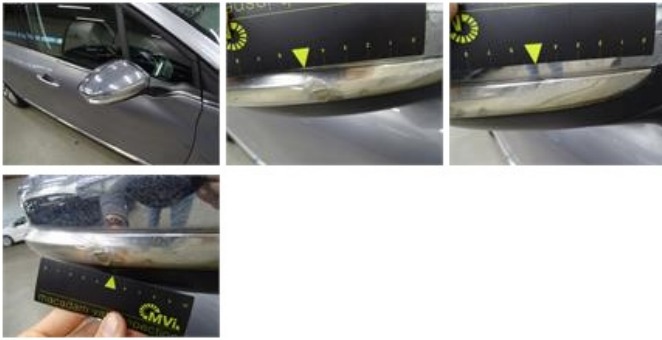
Mirror side blinker R, Broken, E - Replace

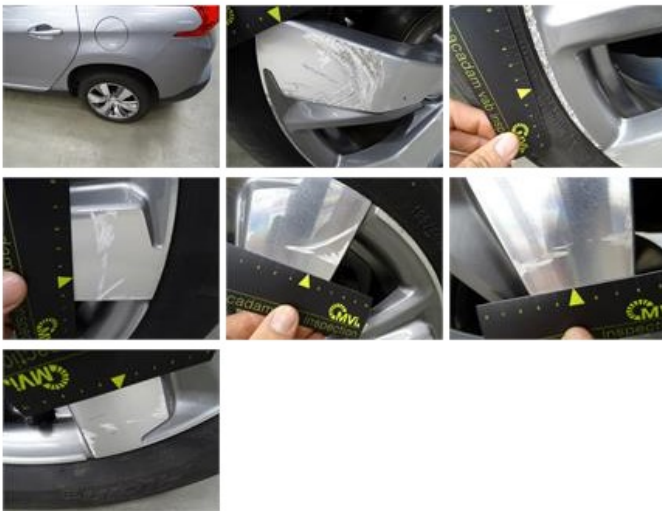
Alloy rim R L polished, Scratch(es), LI - Repair and paint (complete)

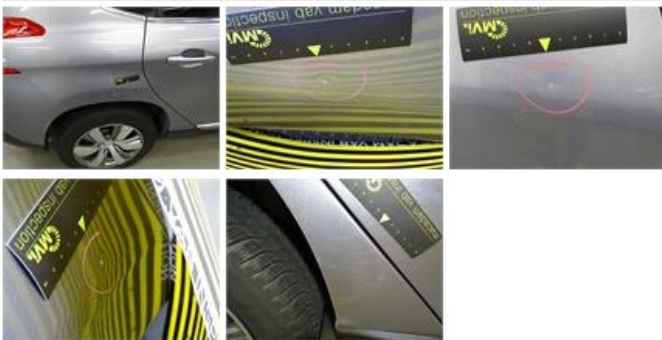
Wing R R, Dent(s) and scratch(es), LI - Repair and paint (complete)

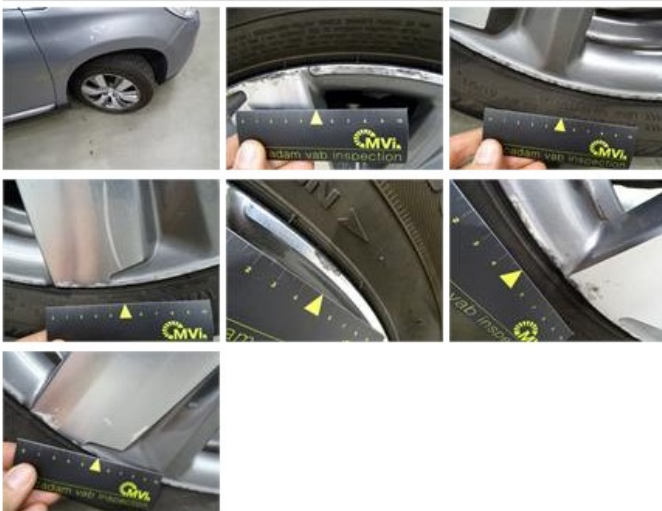
Alloy rim F R polished, Scratch(es), LI - Repair and paint (complete)

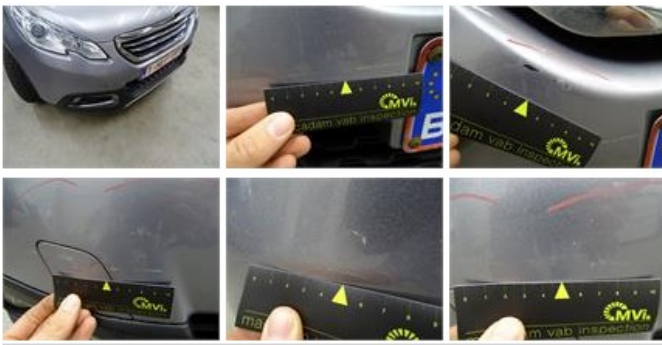
Bumper F, Scratch(es), LI - Repair and paint (complete)

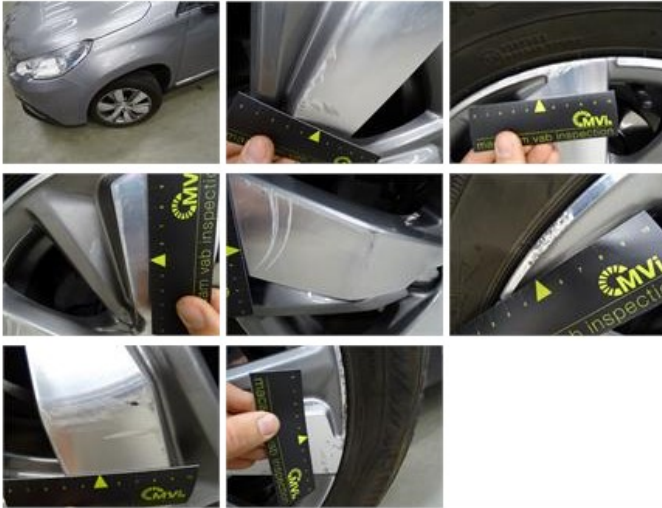
Alloy rim F L polished, Scratch(es), LI - Repair and paint (complete) 95,00

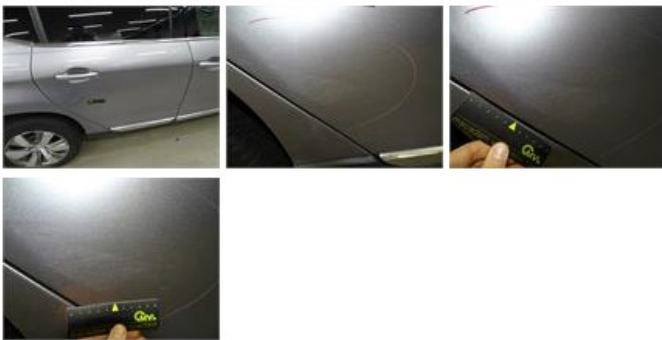
Door R R, Scratch(es), 67 - Polish 0,00

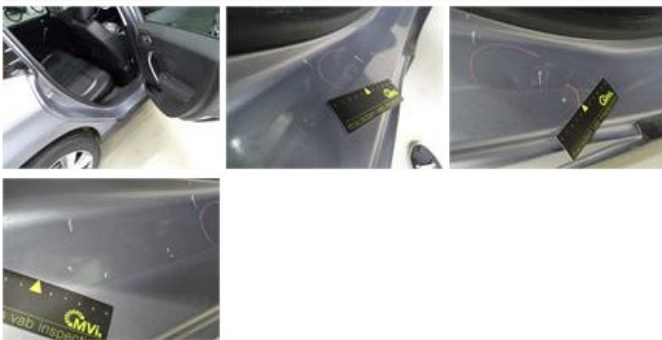
Rocker panel inner R R, Dent(s), LI - Repair and paint (complete) 115,56

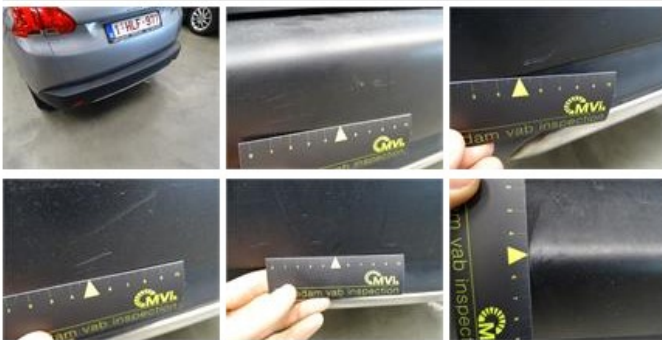
Bumper R, Scratch(es), Smart repair 110,64

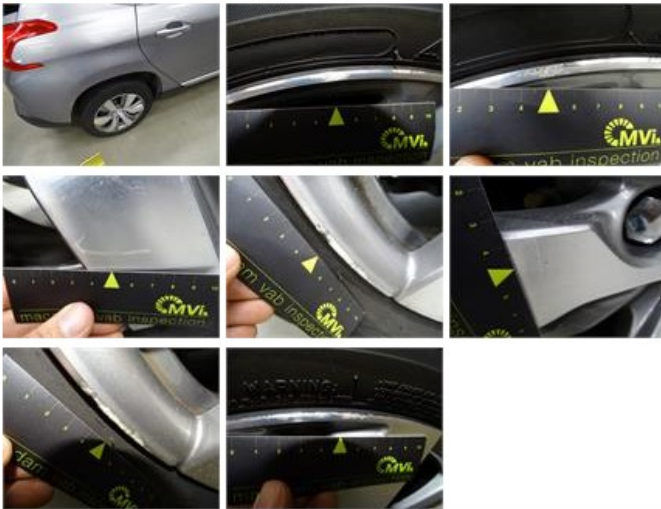
Alloy rim R R polished, Scratch(es), LI - Repair and paint (complete)

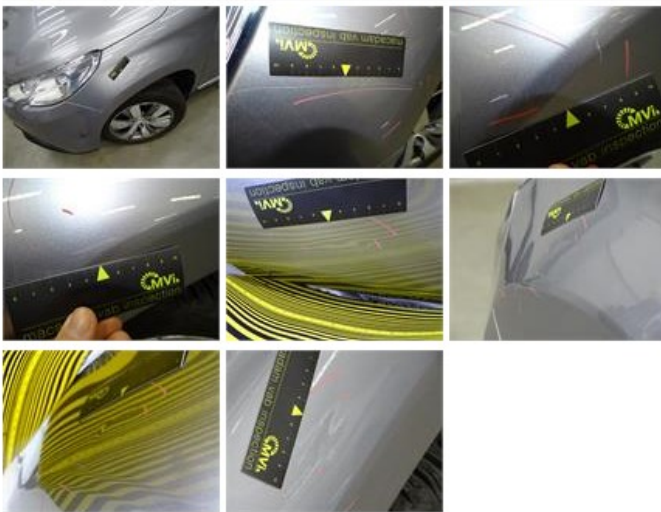
Wing F L, Dent(s) and scratch(es), LI - Repair and paint (complete)
