SKODA Octavia: 1GVL230

Limited Technical Inspection

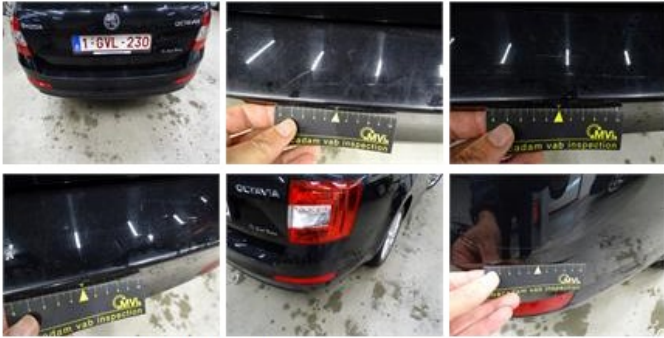
Tailgate, Dent(s) and scratch(es), Acceptable	0,00
<i>No pictures to display</i>	
Alloy rim F R, Scratch(es), Acceptable	0,00
<i>No pictures to display</i>	
Bumper R, Scratch(es), LI - Repair and paint (complete)	211,80
