**VOLVO V70: 1LXD522**

**Limited Technical Inspection**

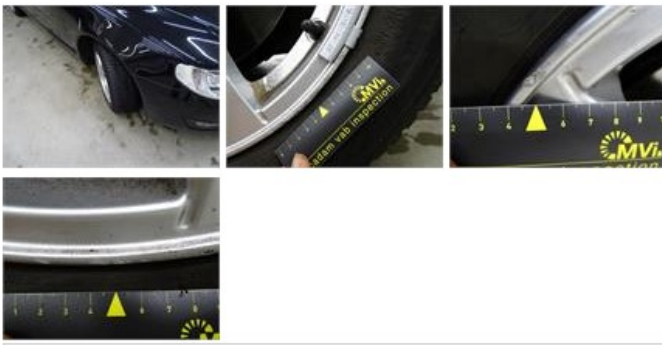
Alloy rim F R, Scratch(es), LI - Repair and paint (complete) 95,00

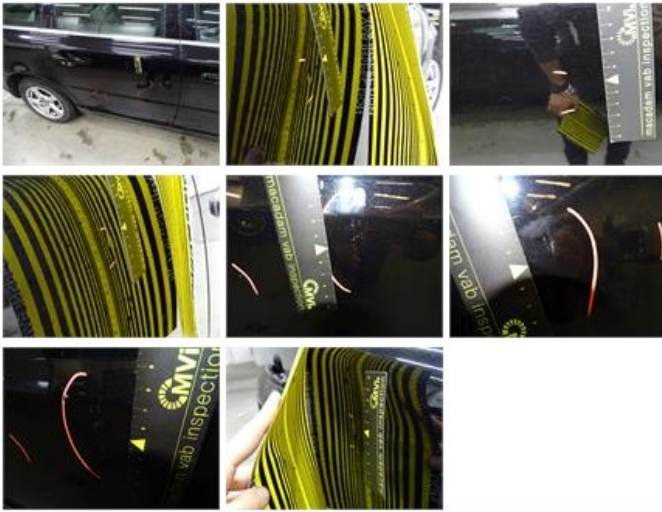
Door R R, Dent(s) and scratch(es), LI - Repair and paint (complete) 382,02

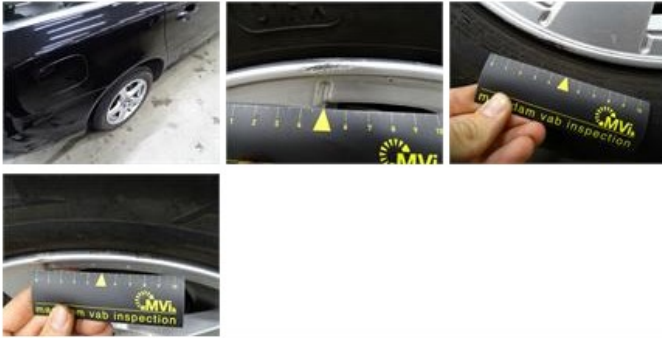
Alloy rim R R, Scratch(es), LI - Repair and paint (complete) 95,00

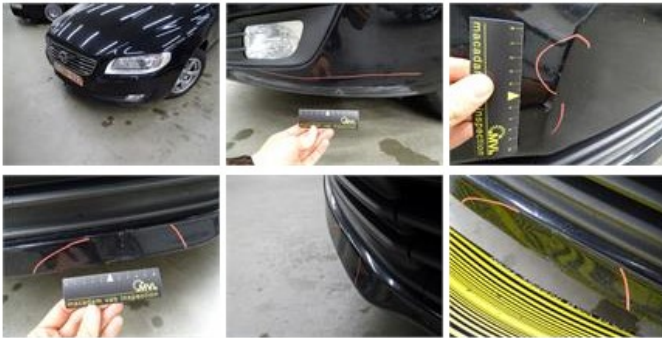
Bumper F, Dent(s) and scratch(es), LI - Repair and paint (complete) 254,16

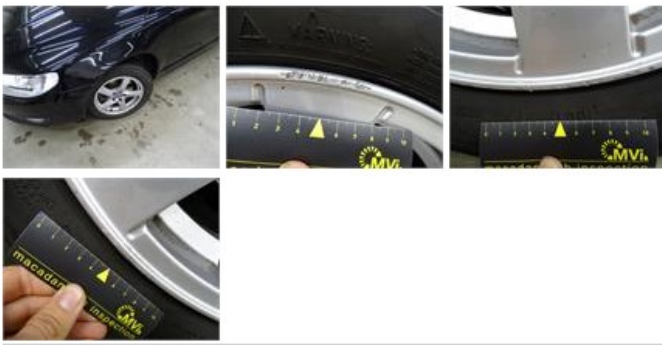
Alloy rim F L, Scratch(es), LI - Repair and paint (complete) 95,00

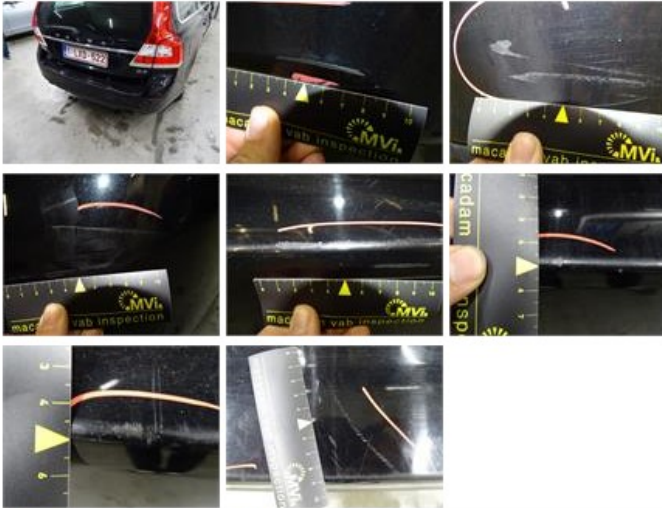
Bumper R, Scratch(es), LI - Repair and paint (complete) 254,16
