VOLVO XC60: 1JJG053

Limited Technical Inspection

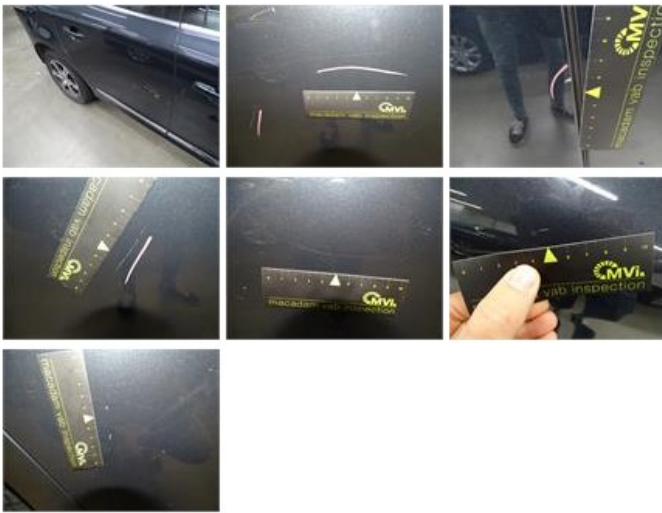
Total cost ex VAT	1550,82
Door R R, Scratch(es), LI - Repair and paint (complete)	382,02

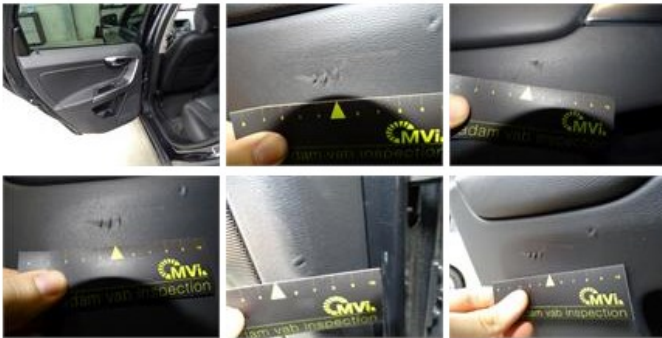
Armrest R L, Tear, Smart repair 64,32

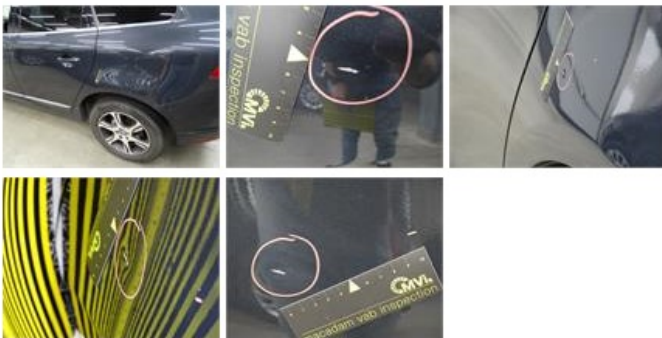
Wing R L, Dent(s) and scratch(es), LI - Repair and paint (complete) 369,84

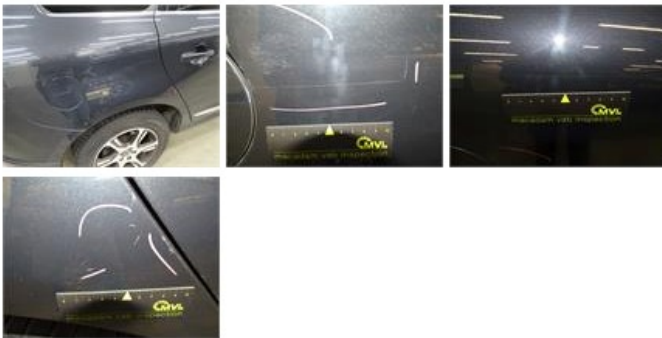
Wing R R, Scratch(es), LI - Repair and paint (complete) 369,84

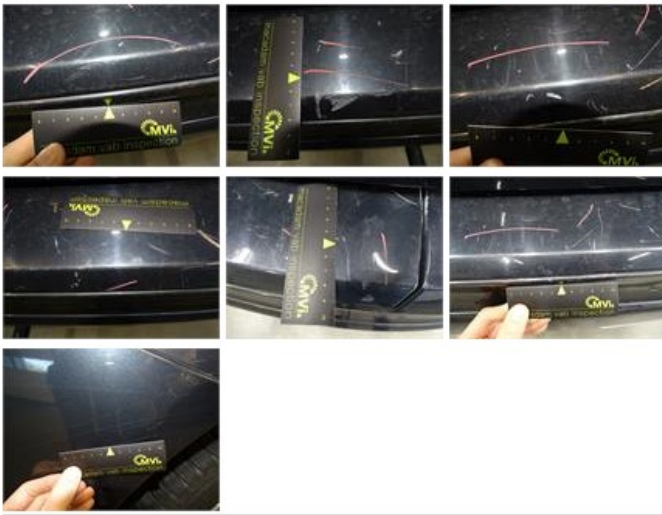
Bumper R, Scratch(es), LI - Repair and paint (complete) 254,16

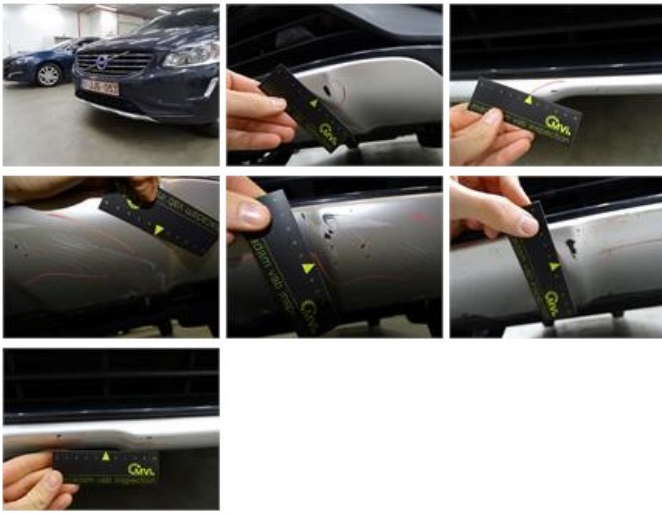
Bumper F M, Scratch(es), Smart repair	110,64
---------------------------------------	--------
