**BMW 2 ACTIVE TOURER: 1LBG641**

**Limited Technical Inspection**

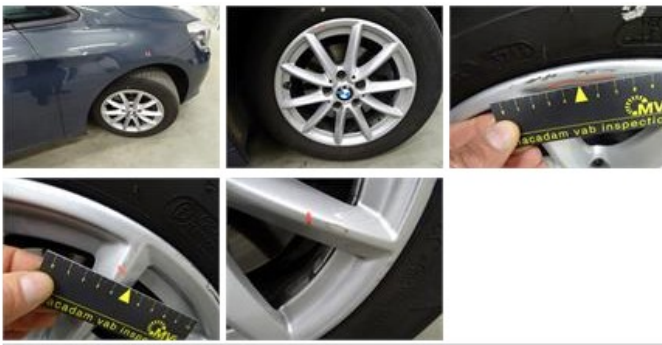
Alloy rim F R, Scratch(es), LI - Repair and paint (complete)	<b>95,00</b>
--	--------------

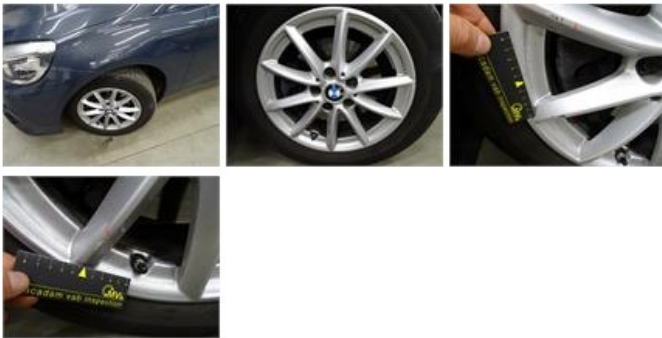
Alloy rim F L, Scratch(es), LI - Repair and paint (complete) 95,00

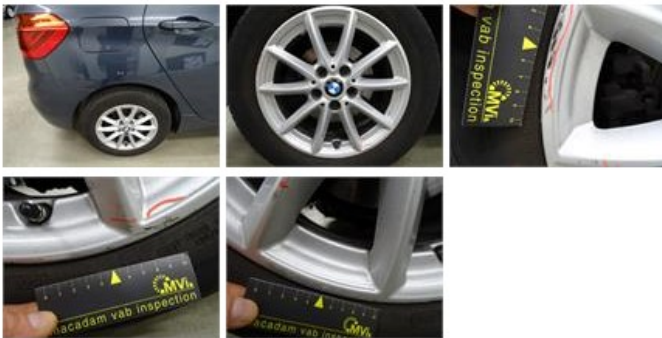
Alloy rim R R, Scratch(es), LI - Repair and paint (complete) 95,00
