Mercedes C: 1KFN074

| Vinnumber: | WDD2052371F192239 | Versionname: | |

Limited Technical Inspection

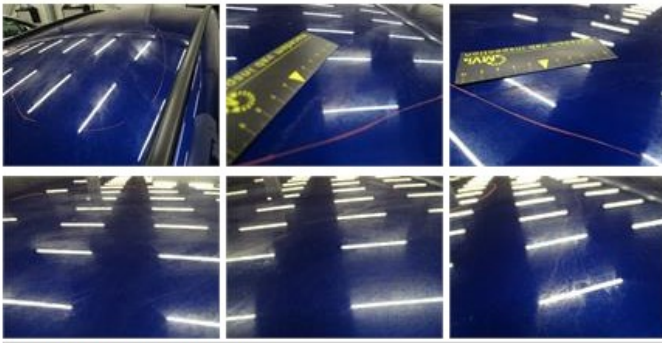
| Roof, Chemical polution, LI - Repair and paint (complete) | 481,50 |
