PEUGEOT 508: 1NBJ776

Limited Technical Inspection

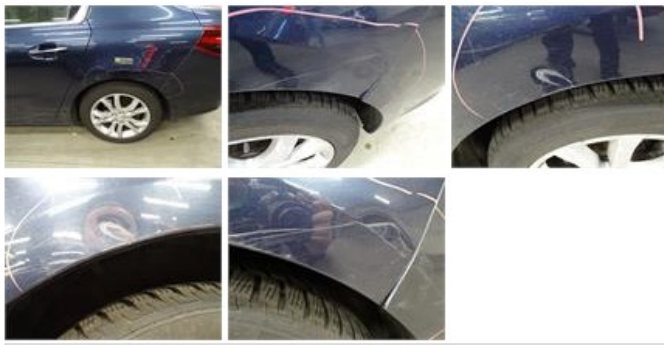
Wing R L, Dent(s) and scratch(es), LI - Repair and paint (complete)	308,20
---	--------

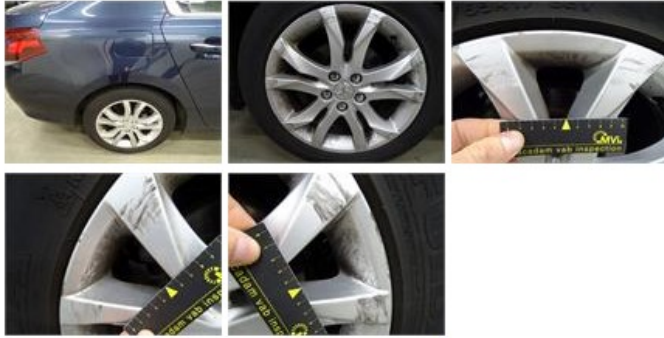
Alloy rim R R, Scratch(es), LI - Repair and paint (complete)

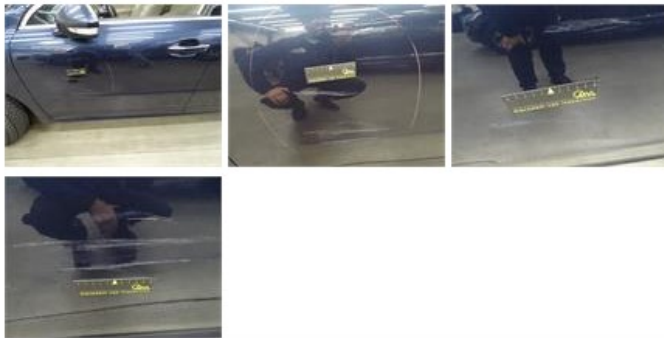
Door F L, Scratch(es), LI - Repair and paint (complete)

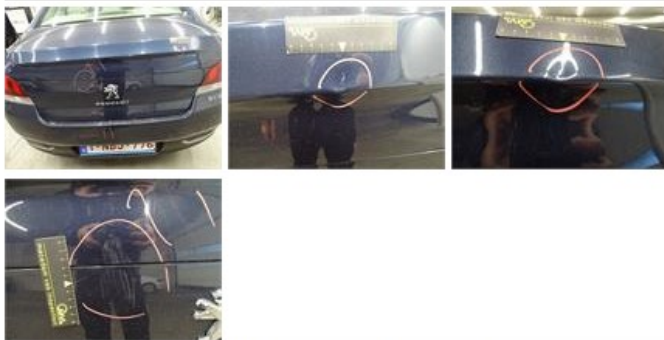
Tailgate, Dent(s) and scratch(es), LI - Repair and paint (complete)

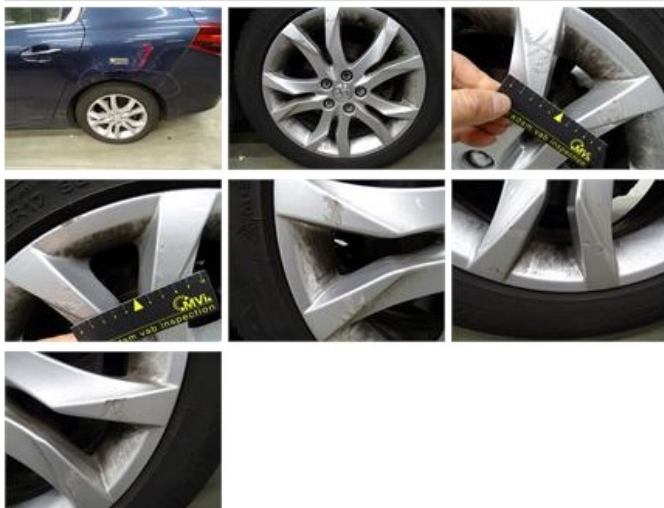
Alloy rim R L, Scratch(es), LI - Repair and paint (complete)

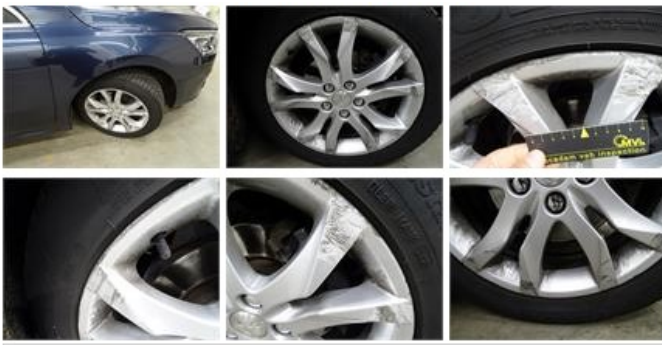
Alloy rim F R, Scratch(es), LI - Repair and paint (complete)

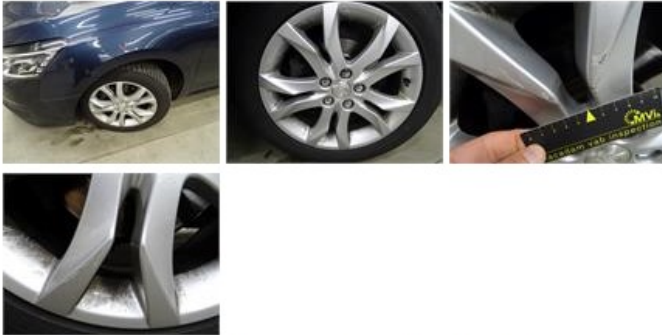
Alloy rim F L, Scratch(es), LI - Repair and paint (complete) 95,00

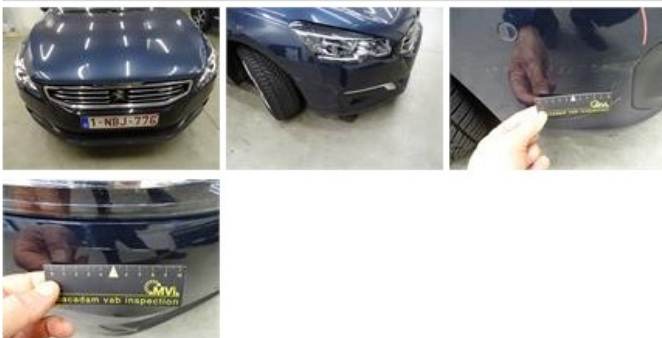
Bumper F, Scratch(es), LI - Repair and paint (complete) 211,80

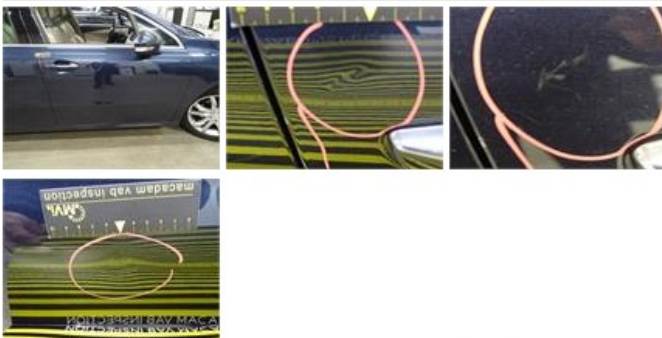
Door F R, Dent(s) and scratch(es), LI - Repair and paint (complete) 318,35

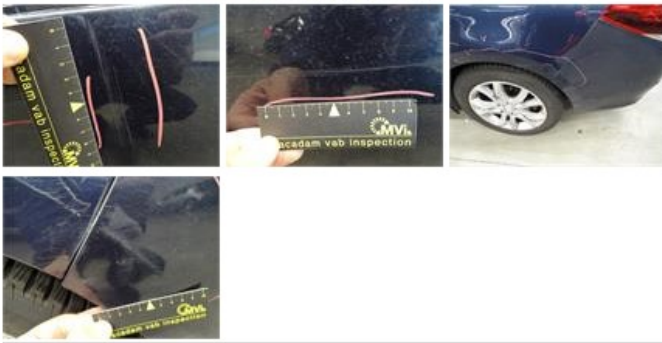
Bumper R, Dent(s) and scratch(es), LI - Repair and paint (complete) 211,80
