VOLKSWAGEN Crafter 35 LWB HR: 1CC1822

Limited Technical Inspection

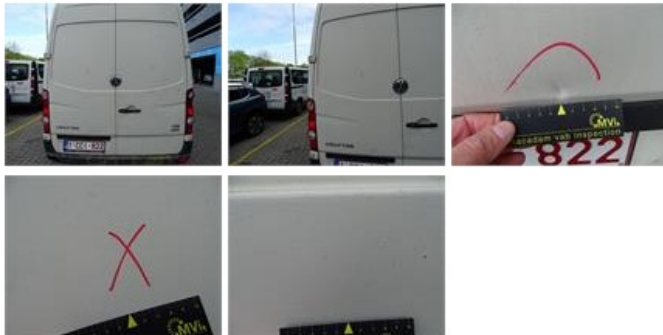
Trunk door R L, Dent(s) and scratch(es), It - Spot repair

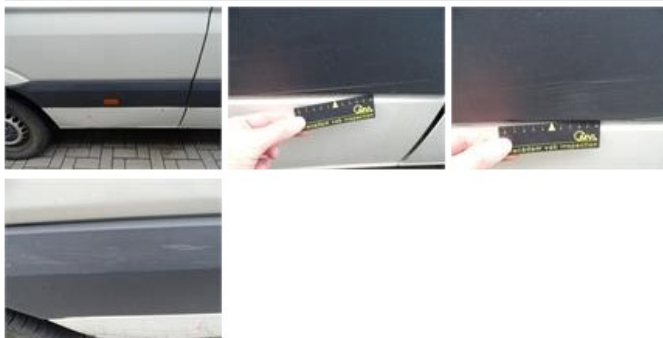
Door moulding Lower R R, Scratch(es), E - Replace

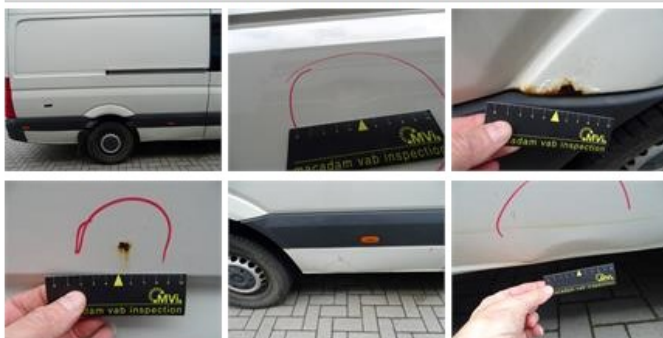
Wing R R, Dent(s) and scratch(es), LI - Repair and paint (complete)

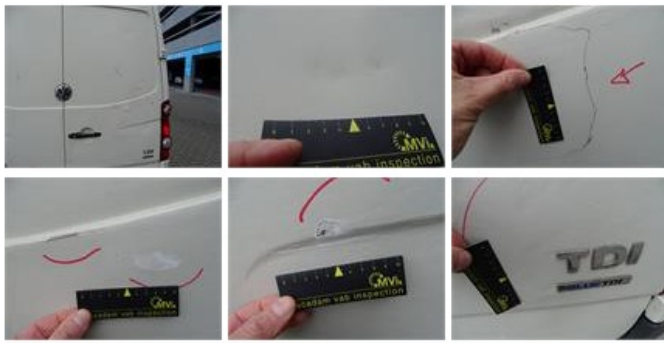
Trunk door R R, Dent(s) and scratch(es), It - Spot repair

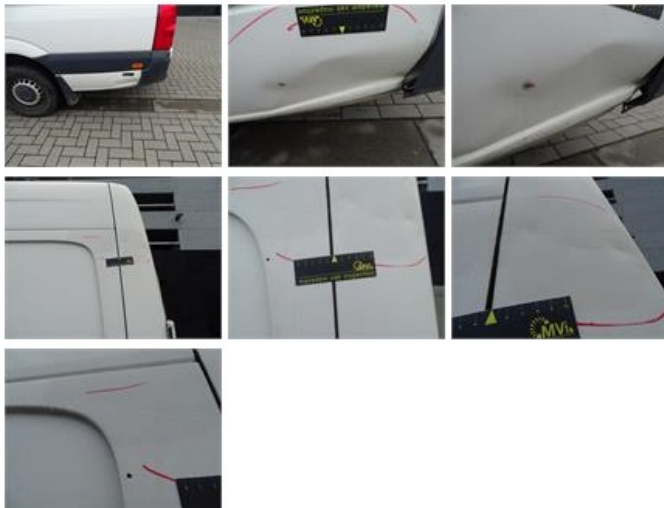
Wing R L, Dent(s) and scratch(es), LI - Repair and paint (complete)

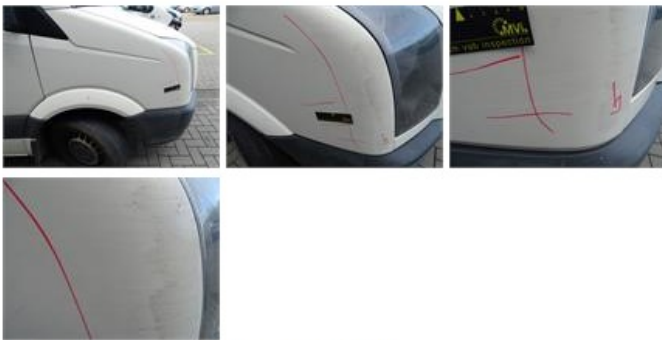
Wing F R, Scratch(es), LI - Repair and paint (complete)

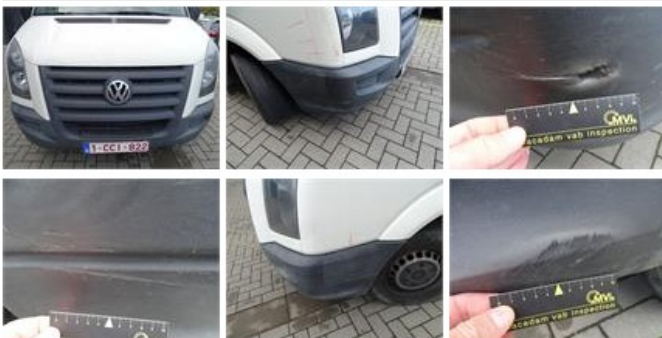
Bumper F, Dent(s) and scratch(es), Smart repair
