SKODA OCTAVIA COMBI: 1PHP674

Limited Technical Inspection

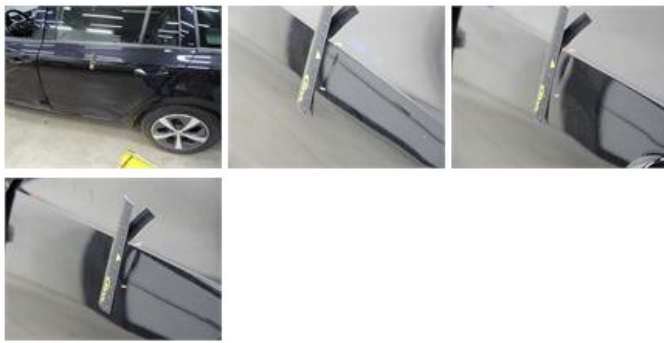
Total cost ex VAT	640,80
Alloy rim F R polished, Scratch(es), Acceptable	0,00
<i>No pictures to display</i>	
Door R L, Dent(s), PDR - Paintless dent repair	63,00

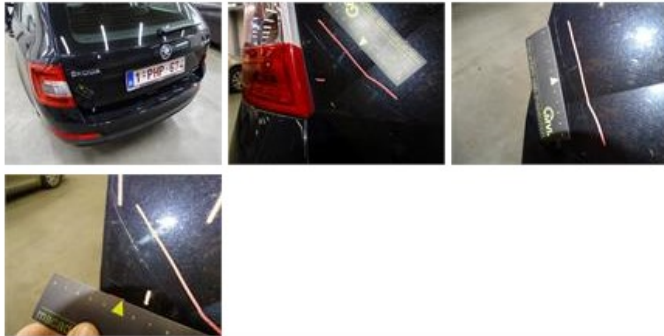
Tailgate, Scratch(es), LI - Repair and paint (complete) 301,68

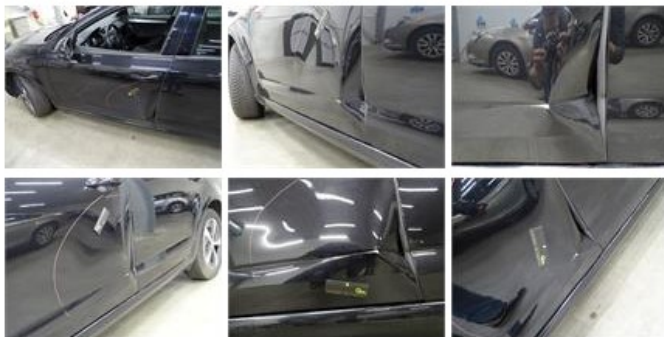
Door F L, Dent(s) and scratch(es), Le - Replace and paint 0,00
